Reconnaissance and learning after the February 6, 2018, earthquake in Hualien, Taiwan

Abstract

Keywords Seismic reconnaissance · 0206 Hualien earthquake · Milun fault · Near-fault ground motion · Building collapse · Bridge · Liquefaction · Non-structural component

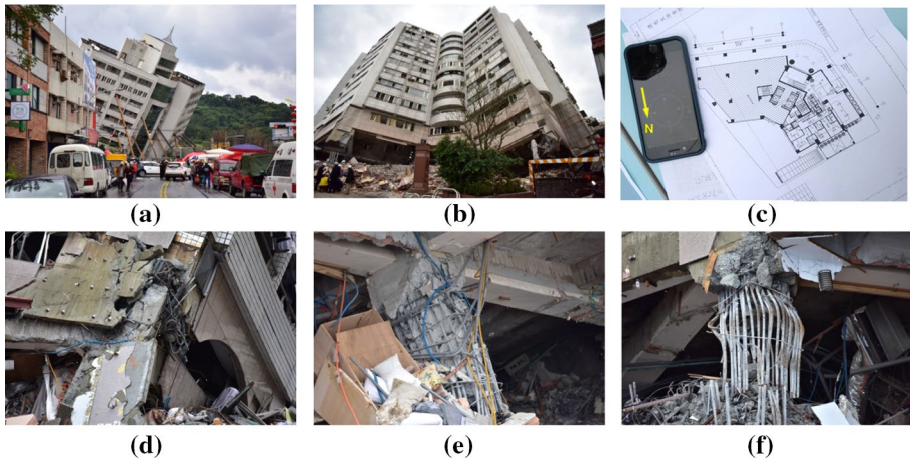
The collapse of this 12-story reinforced concrete (RC) building resulted in the severest number of fatalities, i.e., fourteen out of the total of seventeen in this earthquake. Figure 8a, b respectively show the front and rear sides of the collapsed building, which was built in 1994. The yellow steel struts shown in Fig. 8a are temporary measures to prevent the building from further collapse, which might threaten the lives of the rescuers. The floor plan of the building (Fig. 8c) indicates that the front of the building is to the south-west. In addition, the building is relatively plan-asymmetric. Due to the significantly high peaks of the E-W acceleration response spectra between 1.5 s and 2.5 s (Fig. 6), the building whose dominant vibration period was highly likely within the stated period range collapsed toward the front (i.e., the south-west direction). It is worth noting that the first and second stories of the building were commercially used as a hotel with large open spaces in its lobby/reception hall. Figure 8d–f show the damaged columns that had overly large spacing of stirrups, which was approximately equal to 25 cm to 30 cm. In addition, the splices of all the column reinforcements appeared at the same height (Fig. 8f), which was contrary to the

Fig. 8 **a** Front view, **b** back view, **c** drawing of floor plan, **d** corner column, and **e** and **f** bottom columns of the collapsed 12-story mixed-use apartment block

current code requirements (CICHE 2011). Figure 8f shows that the column moved upward and failed where splicing of reinforcements was deficient.

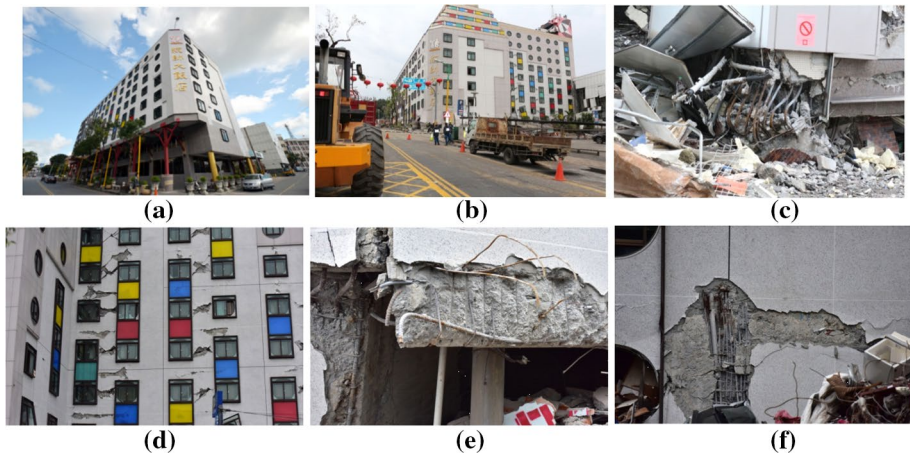
The collapsed hotel was built forty years ago, i.e., in 1978. Figure 9a, b show the appearances of the hotel before and after this seismic event, respectively. Except for the colorful peripheral slender columns, the building essentially overhung the second and above floors (Fig. 9a). After the seismic event, because the bottom two stories were completely crushed, the building appeared as if the third floor was at ground level (Fig. 9b). Because the bottom

Fig. 9 Appearances of the hotel **a** before and **b** after the earthquake. **c** Crushed column, **d** shear cracks, **e** damaged beam, and **f** damaged beam of the collapsed hotel

story of this hotel had large open spaces used for reception, the number of RC walls of the bottom story were fewer than those of the other stories. Moreover, it was very possible that the seismic design and analysis of this aged building neglected the effects of partition walls, i.e., only the beam–column frame structure was considered. With this possible discrepancy between the actual building and the idealized analytical model, the presence of significantly different amounts of RC walls between the bottom story and the other stories very likely resulted in a soft-and-weak bottom story. In addition, without appropriate amounts of walls, the bottom columns probably sustained excessive axial loads during the earthquake. Figure 9c clearly shows that the columns' main reinforcements, which were confined with sparse stirrups, bulged outward, i.e., buckled. According to Fig. 9c, the spacing of the sparse stirrups appears to be greater than 30 cm. Because of the large width-to-height ratio of the building and because the bottom columns had deficient bearing capacities, the soft-and-weak bottom story eventually led to a “sit-down” type of collapse. In comparison, the collapsed 12-story mixed-use apartment (Fig. 8) had a smaller width-to-height ratio in the collapse direction (i.e., the south-west direction). In the light of Fig. 8c, the eventual collapsed form of the mixed-use apartment was a “knee-down” type (Fig. 8a). Perhaps, without the yellow steel struts (Fig. 8a), the mixed-use apartment might have been totally overturned during aftershocks. In such a case, the eventual collapsed form of the mixed-use apartment would be a “lie-down” type.

Figure 9d shows the inclined shear cracks of the exterior columns. Some of the shear cracks are cross-shaped, composed of two inclined cracks centered on one point. The column lengths shortened by windowsills (i.e., the deformations of columns restrained by windowsills) might be the main cause of the shear cracks occurring in the middle of the columns. Figure 9e indicates that the ends of the beams' bottom reinforcements were bent downward. In contrast, according to the latest suggestion of RC construction practice (CICHE 2011), the ends of the beams' bottom reinforcements should be bent upward into the connected columns to prevent damage to beam-to-column joints. Figure 9f depicts a damaged beam-to-column joint without sufficient numbers of stirrups in the joint.

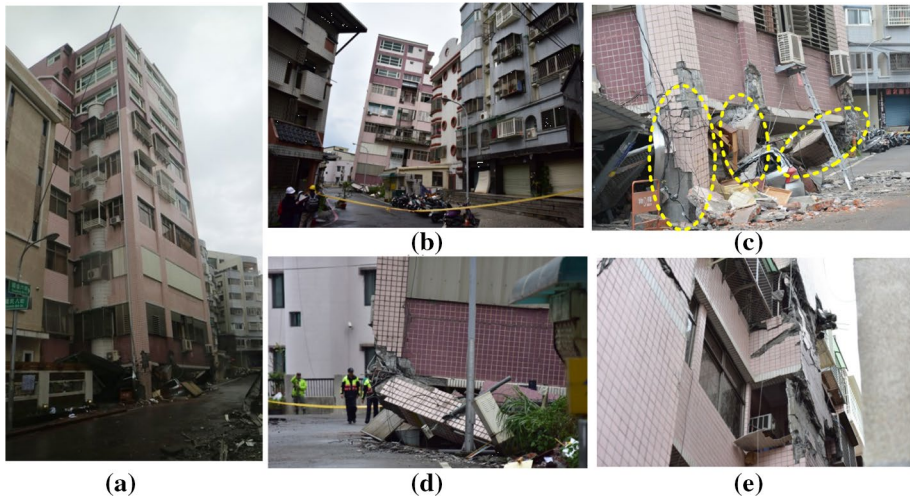
Figure 10a, b show the front and back of the tilted 9-story apartment building, which was built in 1994. Figure 10c is a close-up photograph of the bottom story shown in Fig. 10a. The bottom story of this building was used as a parking lot. Figure 10c indicates that there were two spans (i.e., three columns) along the direction shown in the photograph. The front, middle, and back columns circled in yellow were all bent at their tops. In addition, all

Fig. 10 **a** Front and **b** back views of the collapsed 9-story apartment building. **c** and **d** Close-up photographs of the bottom story shown in **a** and **b**, respectively. **e** Exterior walls of the collapsed building

three columns were inclined toward the inside of the building, and the inclinations sequentially increased from the front column to the back column (Fig. 10c). As a result, the extent of the damages at the tops of the three columns sequentially increased from the front to the back columns. In detail, the top of the front column remained joined to the upper column. In contrast, the top of the middle column was almost entirely separated from the above column. Additionally, the surface of the break at the top of the middle column appeared smooth and there appears to be almost no reinforcements going through that surface. The back column, which was the most severely damaged among the three columns, was almost laid down as a rigid block. The back column shown in Fig. 10c can also be seen from the rear side of the apartment building shown in Fig. 10b, d. Figure 10d is a close-up photograph of the bottom story shown in Fig. 10b. Figure 10d indicates that the back column remained essentially intact except that the column's top was broken. The reinforcements and stirrups at the top portion of the back column were insufficient (Fig. 10c). Additionally, the appearances of the 2nd-story columns atop the three 1st-story columns were all torn off at different lengths and this sequentially increased from the front column to the back column (Fig. 10c). From Fig. 10d, the ends of the reinforcements of the beam connected to the back column were bent downward. Similarly to the discussion associated with Fig. 9e, the bending direction for the ends of the bottom reinforcements of the beams is upward rather than downward. Figure 10e shows the broken exterior walls and the detachment of the exterior tiles of the 9-story apartment building. From the broken section of the exterior walls, there seem to have been very few reinforcements in the exterior walls.

In light of the above-mentioned substantially unequal inclinations and damage extents of the three bottom columns shown in Fig. 10c, the frame consisting of these three columns very likely underwent rotation-induced out-of-plan displacements. In other words, the apartment building was probably plan-asymmetric, which had stiff and flexible sides at the front and back columns of Fig. 10c, respectively. In addition, according to the situations of the reinforcements and concretes exposed at the tops of the bottom columns,

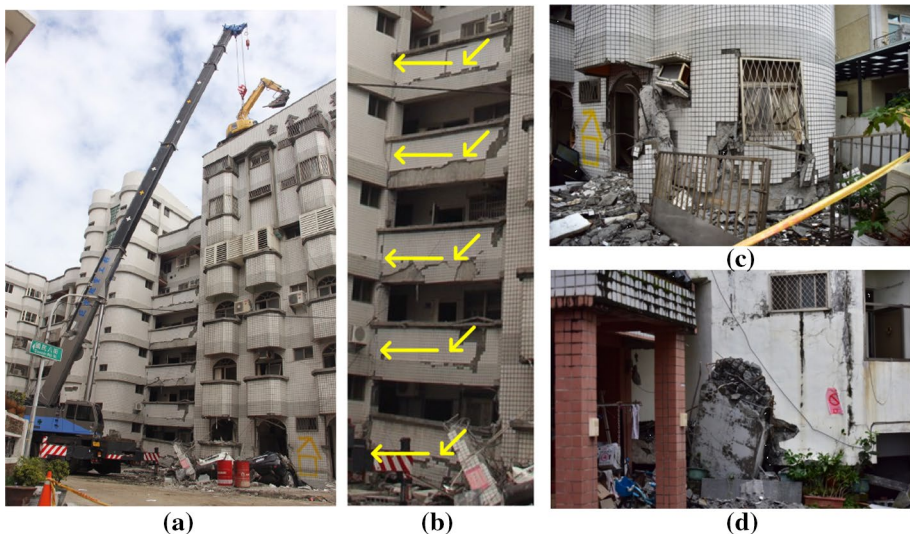
Figure 11a shows the collapsed 6-story apartment building, which was within an approximately 1-min walking distance from the aforementioned 9-story building (Figs. 7 and 10). The collapsed 6-story apartment building was constructed in 1992. Unlike the 9-story building (Fig. 10), which had a knee-down collapse, the bottom story of this 6-story apartment building (Fig. 11a) was also used as a parking lot and it displayed a sit-down collapse. This implies that the bottom-story parking lots with their open spaces and fewer partition walls caused soft bottom stories and this led to the collapse of the building. Furthermore, the possible translation–rotation coupled displacements of the 9-story building (Fig. 10) resulted in a knee-down collapse, such that the damages to the columns were unevenly distributed (Fig. 10c). In contrast, the sit-down collapse of the 6-story building (Fig. 11a) implies that the displacement demands of its bottom columns were approximately equal, i.e., only translational displacements occurred.

The central part of Fig. 11a (the exterior walls of the balconies of all stories) are magnified in Fig. 11b for clarity. These exterior walls have similar patterns of cracks, as indicated

Fig. 11 **a** Front view of the collapsed 6-story apartment building and **b** a magnification of the central part of **a**. **c** Front and **d** back close-up photographs of the collapsed building

by the yellow arrows shown in Fig. 11b. In detail, each of these cracks started at the top right corner of the exterior wall of the balcony and then propagated left and downward with an approximate 45° inclination. Once the crack touched the top surface of the slab of the balcony, it propagated continuously and horizontally to the left side of the balcony. This pattern of cracks implies that the shear force was transferred at the right sides of the balconies. Additionally, there were weak junction surfaces between the slabs and the walls of the balconies. Figure 11c, d show the front and back walls of the apartment building on the ground. While the building settled, there should be substantial vertical reaction forces. The iron-grated window shown in Fig. 11c, which was a weak region of the wall, was extruded outward. The form of the flaked concrete extending out of the wall shown in Fig. 11d was similar to that of the window shown in Fig. 11c. This might reflect that the flaked concrete was a weak region of the back wall. Therefore, it is unsurprising to find that the quality of the concrete exposed at this weak region was poor (Fig. 11d).

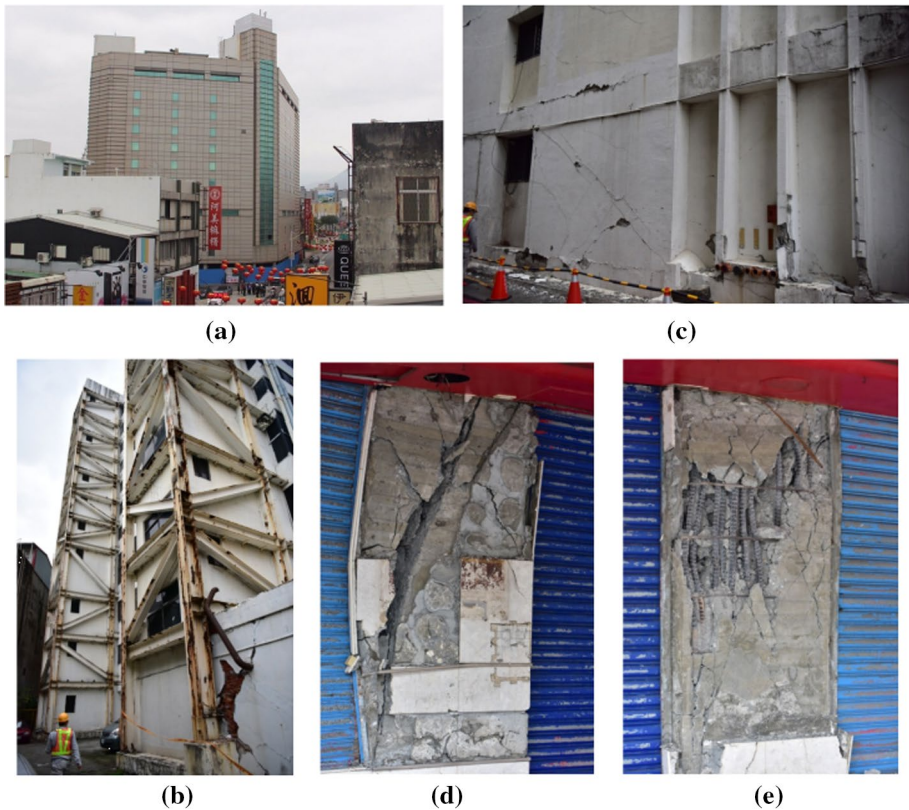
The damaged 12-story department store (Fig. 12a) was opened in 1991. After being damaged during the 1999 Chi-Chi earthquake, the department store was once repaired and retrofitted. The department store was moved to another building in 2009. Hence, the building was abandoned and empty when the 2018 Hualien earthquake occurred. The staircases at the back of the building were retrofitted with steel braced frames after the 1999 Chi-Chi earthquake (Fig. 12b). The staircases and the added steel braced frames remained essentially intact after the 2018 Hualien earthquake. In contrast, a brick wall appearing at the right bottom corner of Fig. 12b was cracked. This might imply that the added steel braced frames performed well such that the building was protected to some extent. Figure 12c shows that the lateral walls of the building were damaged with diagonal shear cracks. Moreover, the exterior columns of the bottom story shown in Fig. 12d, e were severely damaged with a deep and wide shear crack and a flexure-shear crack, respectively. The spacing of the stirrups shown in Fig. 12e was extraordinarily large, which was approximate 25 cm. Additionally, most of the decorated white stone panels encasing the columns had flaked off (Fig. 12d, e). The severely damaged building (Fig. 12) was eventually demolished after the Hualien earthquake.

Fig. 12 Photographs of the damaged 12-story department store: **a** overall view, **b** retrofitting with a steel braced frame, **c** side view, and **d** and **e** severely damaged bottom columns

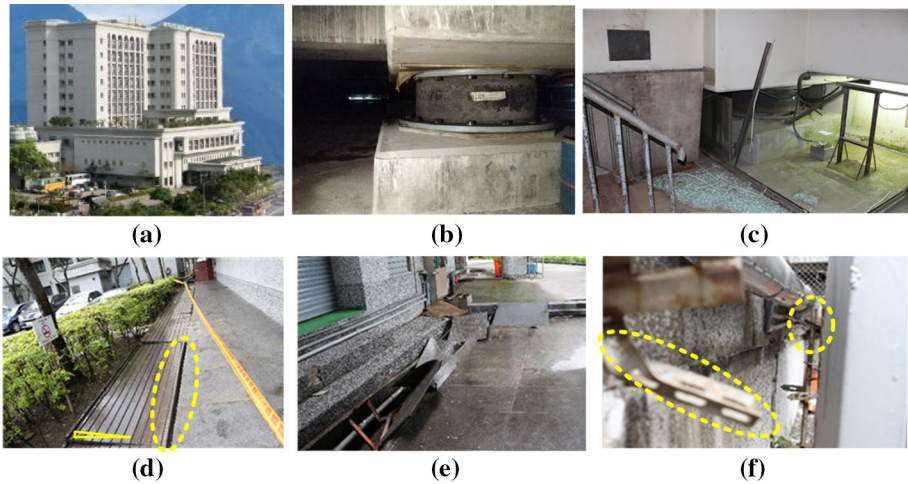
The base-isolated building is a regional hospital with ten floors and two base floors (Fig. 13a) located approximately 2 km away from the Milun Fault. The second base floor, abbreviated as B2F, is dedicated to installation of the isolators, which are lead rubber bearings (LRB) (Fig. 13b). There were no structural damages found in the building as a whole, including the isolators and the upper structure. Nevertheless, damages to some non-structural components were observed (Fig. 13c–f). Figure 13c shows the broken glass that was used for protecting and encasing the displayed seismic instruments. The reserved gap allowing lateral deformations of LRBs is 70 cm. The planks covering the reserved gap were inclined and pushed aside, leaving a space between the planks and the pavements of walkways (Fig. 13d). Some other segments of the reserved gap were covered using checker plates (Fig. 13e), which were damaged and disordered. Additionally, Fig. 13f shows damaged piping supports. Besides the seriously deformed piping support indicated on the left of Fig. 13f, the end of the right piping support was detached from the pipe (Fig. 13f). Although these non-structural damages did not affect the operation of the hospital, it shows that more attention to the details of non-structural components of buildings with seismic isolators is needed in comparison with conventional buildings.

Fig. 13 Photographs of **a** the base-isolated building, **b** a lead rubber bearing, **c** broken glass, **d** gaps induced by the deformation of isolators, **e** damaged checker plates, and **f** damaged piping supports

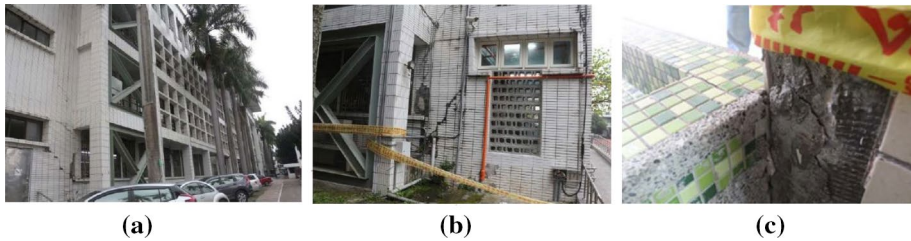
Fig. 16 **a** and **b** Cracked brick walls. **c** A cracked column of a four-story school building

Figure 16a, b show the cracks in brick walls surrounding the lavatories of a four-story school building that was retrofitted with steel braces and had shear walls added in 2010. Figure 16c shows the cracks induced by pounding between a column and a sink in the other school building. The cracked column and the basin were from one two-story building and one four-story building, respectively. The two- and four-story buildings, which were built in 1984 and 1997, respectively, were arranged in an L-shape and separated with expansion joints. The basin was added to the second floor of the four-story building during the seismic retrofit conducted in 2014. However, there were no reserved gaps between the sink and the column. Because of the different vibration periods of the two buildings, the collision between the sink and the column during ground shakings was inevitable.

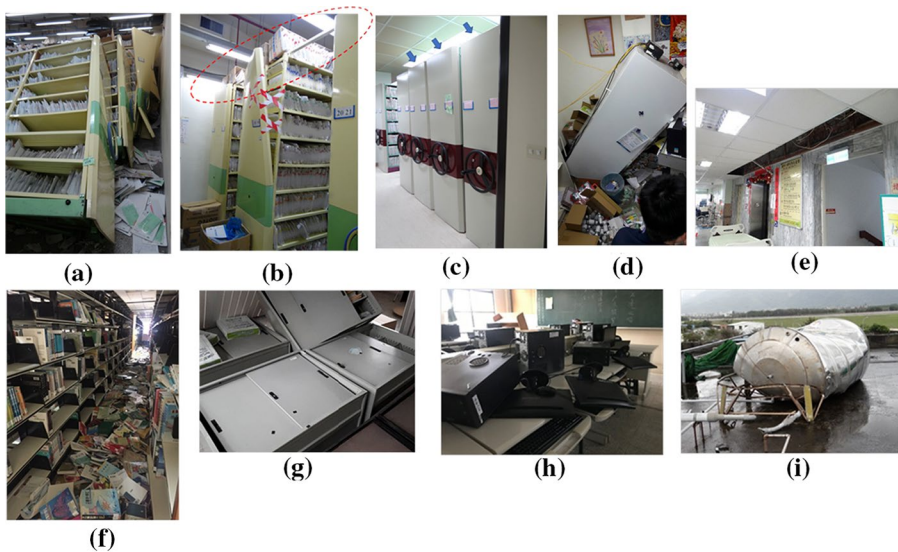
Besides damages to building structures, the damages to non-structural components of buildings are also discussed. Figure 18a–c show the different extents of damage to shelves of medical history sheets in a hospital. The shelves shown in Fig. 18a, b were identical and were moveable on their own wheels. Nevertheless, the countermeasures adopted for resisting seismic forces on the shelves were different. The shelves of Fig. 18a were fixed to the floor slabs via angle steels connecting the shelves' bottoms and the floor slabs with bolts. In contrast, the shelves of Fig. 18b were connected to each other via the links at the shelves' tops. Because of the insufficiency of the bolts connecting the shelves' bottoms and the floor slabs, the shelves in Fig. 18a were overturned. In contrast, because the added top links substantially increased the width-to-height ratio of the shelves, the only damage to the shelves in Fig. 18b was warped sideboards. The shelves shown in Fig. 18c were of another type that was moveable on sliding rails mounted on the floor slabs. Only some sideboards of the shelves shown in Fig. 18c were slightly inclined. It was also noted that the normal

Fig. 18 a–c Damaged shelves for medical history sheets in a hospital. **d** An overturned medicine refrigerator. **e** Fallen ceilings in a hospital. **f** Books fallen from bookshelves. Overturned **g** filing cabinets and **h** desk computers. **i** A damaged water storage tank

vectors of the vertical planes of the shelves shown in Fig. 18a, b were in a NE-SW direction that was almost in line with the direction of most of the velocity pulses observed in the Hualien earthquake (Fig. 3). In other words, the velocity pulses were essentially along the short direction of the shelves shown in Fig. 18a, b. In contrast, the direction of the shelves shown in Fig. 18c was 90° rotated relative to the shelves shown in Fig. 18a, b. In other words, the velocity pulses were essentially along the long direction of the shelves shown in Fig. 18c. In addition, in light of the reserved large spacing between the shelves (Fig. 18a), a domino effect might be one of the reasons causing the overturning of a series of shelves, as shown in Fig. 18a. In contrast, the close spacing between the shelves shown in Fig. 18c might prevent the occurrence of a domino effect.

The other damages to non-structural components commonly observed in hospital buildings were the overturning of medicine refrigerators (Fig. 18d) and the fall of ceilings (Fig. 18e). The fallen ceilings shown in Fig. 18e were in front of the doors of elevators and the entrance to stairs. It is worth noting that no matter what the categories of the buildings (hospital, school, etc.), most of the falls of suspended ceilings occurred at the peripheral parts of the ceilings. This implies that possible collision between the suspended ceiling and its surrounding structural members (e.g., beams, walls) should be one of the main concerns of the seismic design of such ceilings.

Typical non-structural damages to schools during this seismic event were books falling from bookshelves (Fig. 18f), the overturning of filing cabinets and desk computers (Fig. 18g, h), and damaged water storage tanks (Fig. 18i). Figure 18i shows that the supporting frame of an overturned water storage tank was significantly deformed. This type of water storage tank, made of aluminum, is commonly installed on the roofs of buildings across Taiwan. Nevertheless, their supporting frames seem not to be differentiated for the different heights of buildings. In other words, the supporting frames are sold as accessories to the sets of water storage tanks rather than customized products. Therefore, it appears necessary to establish rational commercial codes or standards for such water storage tanks.

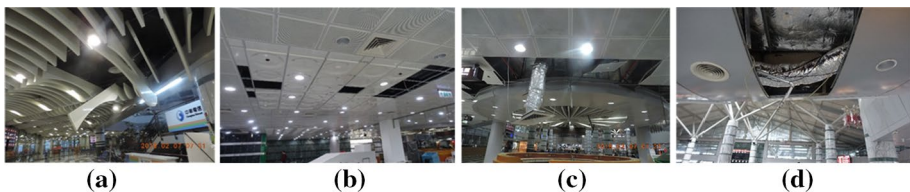
In addition to hospitals and schools, a terminal of an airport (Fig. 19) located approximately 1 km away from the Milun Fault was also examined after the earthquake. This terminal had three floors and one basement floor and was constructed in 2004. The baffle boards (Fig. 19a) and the ceilings, made of punched aluminum plates (Fig. 19b), had fallen during the earthquake, even though the terminal was relatively new. Figure 19c shows a ventilation duct hanging through the hole where the ceilings fell. The damaged sprinkler pipe for firefighting (Fig. 19d) resulted in the leakage of water in the arrival hall.

Fig. 19 **a** Fallen baffle boards, **b** fallen metal ceilings, **c** a ventilation duct hanging through the hole where the ceilings fell, and **d** a damaged sprinkler pipe used for fire-fighting in an airport terminal

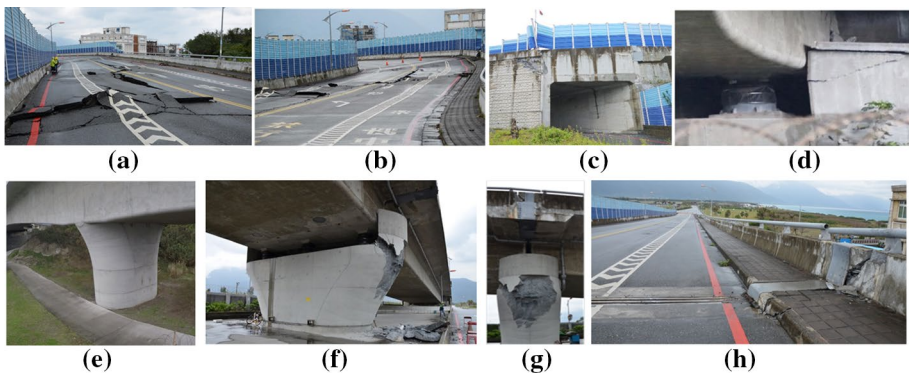
Figure 23a, b show the upheaval of the road embankment approaching abutment A2. In light of the displacements of the land surface shown in Fig. 21b, d, there was a thrust from the embankment toward abutment A2, by which the aforementioned upheaval was manifested. Additionally, that is why the noise barriers at the top of the upper-left corner of the culvert were pushed against each other (Fig. 23c). Figure 23d shows the cracked seismic stopper at abutment A2. This slightly damaged seismic stopper implies an inclined rather than perpendicular collision between the girder and the seismic stopper because abutment A2 is skewed relative to the direction of traffic flow. Pier P2 was intact (Fig. 23e), whereas pier P1 had obvious damage (Fig. 23f, g) caused by the collision between the girder and the seismic stopper. This collision also resulted in the surrounding concrete flaking off pier P1. Nevertheless, through detailed visual inspection, there were no visible flexural or shear cracks at the bottom of pier P1. The damage to the seismic stoppers (Fig. 23d, f, and g) reflects that the seismic stoppers functioned properly. Figure 23h shows the essentially intact expansion joint at abutment A1. Nevertheless, it is noted that the red traffic markings on the opposite sides of the expansion joint were not in line with each other (Fig. 23h).

Fig. 23 **a** and **b** Upheavals of the road embankment approaching abutment A2. **c** The damaged noise barriers above the culvert. **d** The cracked seismic stopper at abutment A2. **e** The intact pier P2. **f** and **g** The damaged pier P1. **h** The expansion joint of abutment A1

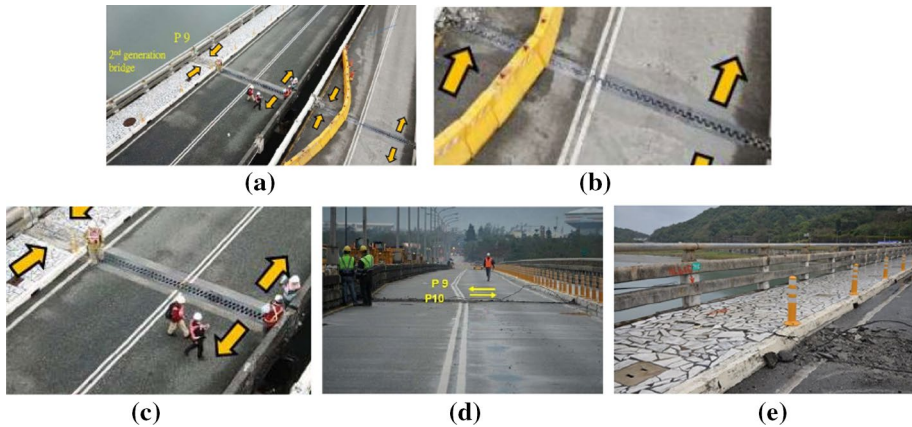
The bridge decks between the expansion joints at piers P9 and P12 were severely damaged. The directions of the yellow arrows in Fig. 25a indicate that the end of the expansion joint at pier P9 of the 2nd-generation bridge (on the side near the 1st-generation bridge) was opened, whereas the other end of the expansion joint was closed. Likewise, the end of the expansion joint at pier P9 of the 1st-generation bridge (on the side near the 2nd-generation bridge) was closed, whereas the other end of the expansion joint was opened. For clarity, Fig. 25b, c, which are magnifications of Fig. 25a, show the expansion joints at pier P9 of the 1st- and 2nd-generation bridges, respectively. From Fig. 21c, the northbound and southbound routes can be viewed as two parallel beams being bent with their tops compressed (i.e., suggesting closed expansion joints) and bottoms tensioned (i.e., suggesting opened expansion joints). Therefore, the non-uniform movements of the expansion joints (Fig. 25a) are consistent with the displacements of the land surface near the Hualien Bridge (Fig. 21c). The deflected white traffic markings between piers P9 and P10 (Fig. 25d) indicate that pier P10 moved northward relative to pier P9, which also reflected

Fig. 25 **a** Expansion joints at pier P9. **b, c** Magnifications of **a**. **d** Deflected white traffic markings between piers P9 and P10. **e** Shattered bridge deck at pier P10

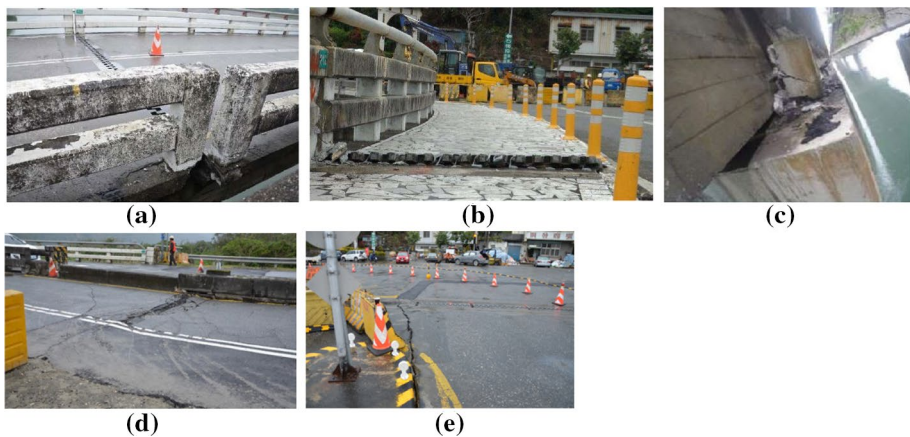
Fig. 26 **a** Southbound route at pier P12. **b** Northbound route at pier P12. **c** Cracked seismic stopper at pier P12. **d** Upheaval of road surface near abutment A1. **e** Cracked road surface near abutment A2

At the barriers at pier P12 of the southbound route (Fig. 26a), an approximately 15-cm transverse dislocation was observed. Additionally, the teeth of the expansion joint at pier P12 of the northbound route were not only transversely dislocated but also pushed upward (Fig. 26b). Because of the aforementioned transverse dislocation, collision between the girder and the seismic stopper resulted in the crack of the seismic stopper at pier P12 (Fig. 26c). The road surfaces near both abutments A1 and A2 were uplifted and cracked (Fig. 26d, e). This might have been caused by the pushing force of the approach slab of the bridge.

is necessary for bridges crossing active faults. For bridges with simply supported girders sitting on neoprene pads or moveable bearings, the large displacement demands caused by the dislocations of active faults may be totally or partially accommodated by the girders' displacements relative to their bearings. The inertial forces transmitted to the substructures are thus reduced. Most of the seismic damages to such bridges likely occur at the bridge decks, expansion joints, and seismic stoppers. Certainly, the most critical challenge is to ensure that the displacement capacities of such bridges are sufficient for preventing the girders from unseating.

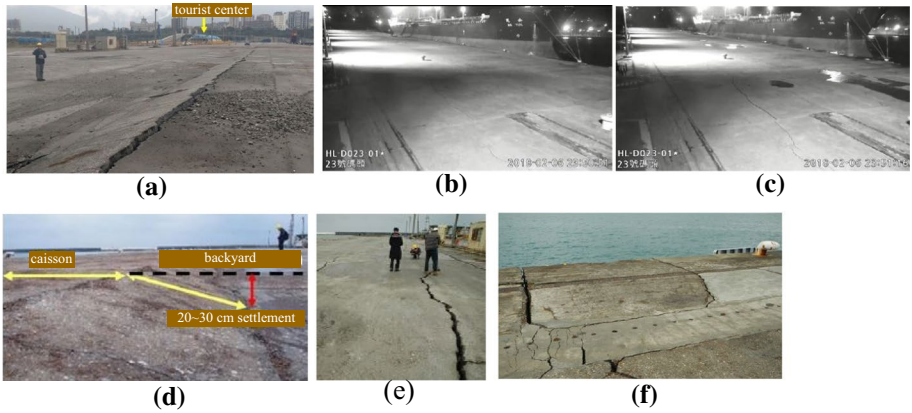
The settlement of back area of wharf No. 23 was approximately 200 mm (Fig. 28a). Besides sands accumulated at some points of wharf No. 23, the border between the caissons and the back area was cracked (Fig. 28a). Nevertheless, the caissons of wharf No. 23 were not damaged, displaced, or settled. Figure 28b, c are images from closed-circuit television (CCTV) installed at wharf No. 23 with recording times at respectively 23:50:51 and 23:51:16 on February 6, 2018. The two recording times, separated by only 25 s, are before and after the strong shaking of the Hualien earthquake. Comparing the two images shows the spurt of underground water and cracks in the pavements caused by the ground shaking. With the CCTV images, the accumulated sands, settlements, and cracks collectively indicate that soil liquefaction happened in this area. The damages to wharf No. 24 shown in Fig. 28d, e were similar to those of wharf No. 23, but the settlement of its back area, which was approximately equal to 200–300 mm (Fig. 28d), was more significant in comparison with that of wharf No. 23. In addition, there was an approximately 90 mm gap between the wave chambers of wharf No. 24 (Fig. 28f) near the turning corner of the wharf, i.e., the side close to wharf No. 25 (Fig. 27b).

Fig. 28 a Accumulated sands and the settlement of the back area of wharf No. 23. CCTV images of wharf No. 23 (b) before and (c) after the strong ground shaking. d The settlement and e the crack of the back area of wharf No. 24. f The gap between wave chambers of wharf No. 24

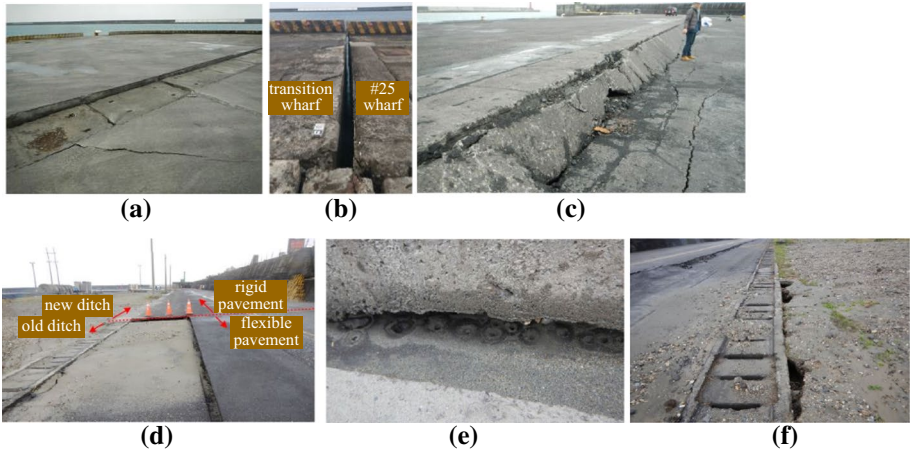
Wharf No. 25 suffered more damage than wharfs No. 23 and No. 24 in this seismic event. A differential settlement appeared on the two sides of wharf No. 25 (Fig. 29a). This earthquake also induced a gap of 80–130 mm between wharf No. 25 and the transition wharf at the turning corner (Fig. 29b). The back area of wharf No. 25 settled to a depth of 500 mm to 600 mm (Fig. 29c). This was the largest settlement among all the wharfs of Hualien Port. Figure 29d–f show images of the western breakwater. Before the Hualien earthquake, parts of the roads on the western breakwater were maintained by repaving roads with rigid pavements instead of the original flexible pavements (Fig. 29d). After the

Hualien earthquake, settlements and cracks occurred in the flexible pavements but not in the rigid pavements. A possible reason for this phenomenon is that the rigid pavements were capable of resisting the settlements induced by hollowing out of the roadbeds, where many sand vents were observed underneath the rigid pavements (Fig. 29e). Figure 29f

Fig. 29 a Differential settlement at wharf No. 25. b A gap between wharf No. 25 and the transition wharf. c Settlement at the back area of wharf No. 25. d The roads, e sand vents, and f hollowed roads and erupted mixtures on the western breakwater

shows the hollowed roads and the erupted mixtures caused by liquefaction at the western breakwater.

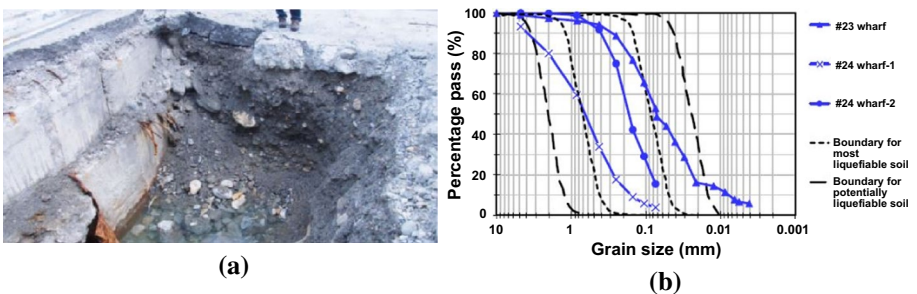
Fig. 30 a Excavated test pit. b Accumulation curves for grain sizes

After the earthquake, Hualien Port Corporation excavated some test pits in the back areas to investigate the compositions of the backfill (Fig. 30). The test pits showed that the backfills are mixtures of large-size gravels, sands, and fine particles that are similar to those found in the settled back areas of CentrePort in New Zealand after the Kaikoura earthquake, 2016 (Cubrinovski et al. 2017). The grain sizes of the erupted mixtures during soil liquefaction at wharfs No. 23 and No. 24 were further analyzed (Hsu et al. 2018). Figure 30b shows the accumulation curves for the grain sizes. According to the unified soil classification system (Casagrande 1952), the erupted mixtures collected at wharf No. 23 are classed as ML (Mud, Low plasticity). Additionally, the erupted mixtures collected at two places at wharf No. 24 are classed as SP (Sand, Poorly graded) and SM (Sand, Mud). In addition to the three accumulation curves for the grain sizes, the boundaries for potentially liquefiable and most liquefiable soils suggested by the Ports and Harbors Association of Japan (PHAJ 1999) are also illustrated in Fig. 30b. The diagram shows that all the erupted mixtures during liquefaction collected at wharfs No. 23 and No. 24 were in the range of potentially liquefiable soils (Fig. 30b). Moreover, because all the settlements of the back areas of wharfs No. 23 to No. 25 are less than 700 mm, the seismic damage levels of these wharfs, whose caissons showed no obvious sliding, inclination or structural damage, are categorized as Level I (i.e., useable level) according to the seismic design guidelines for port structures (PIANC 2001).
