Geological investigation and the influence estimation of WuShentou Dam via LiuChia

Senior Engineer Cheng-Yang Yen

E ENGINEERING CONSULTANTS CO., LTD

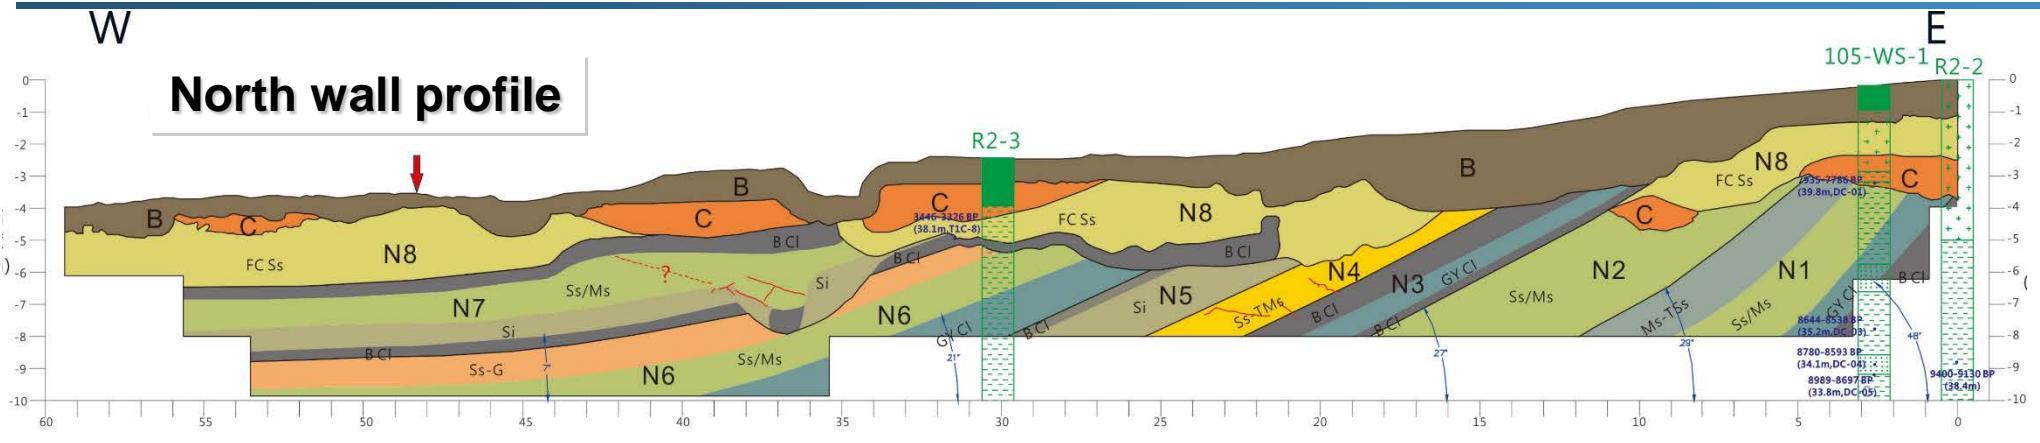
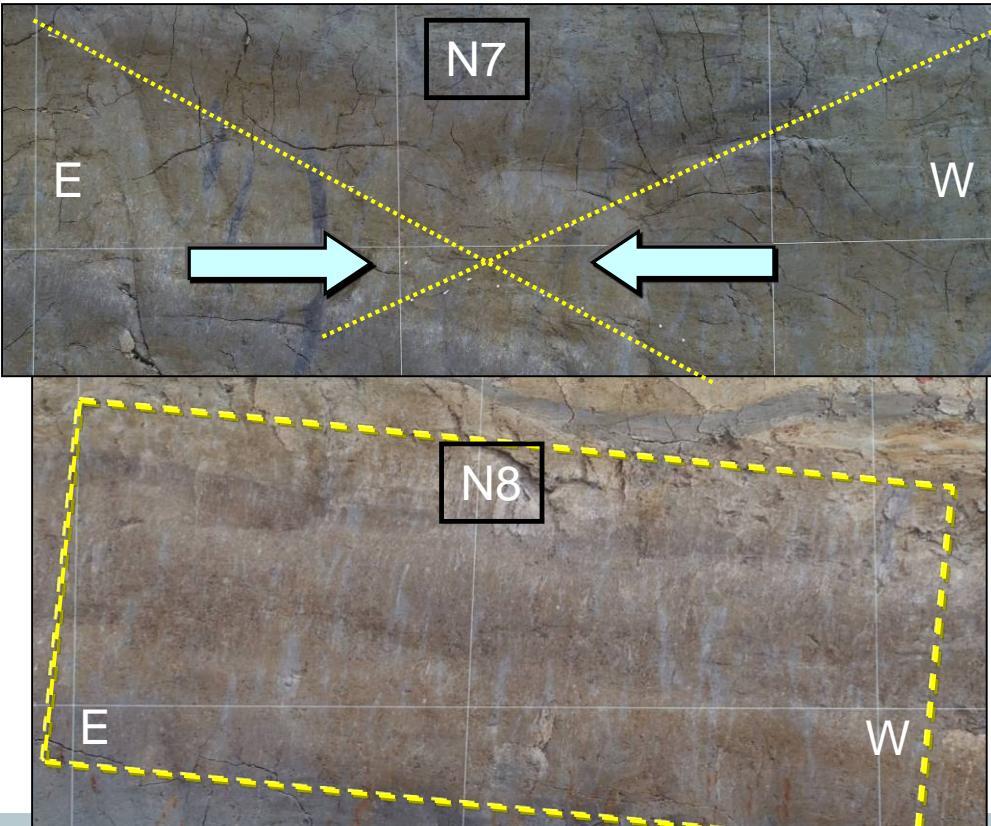
Geological structure interpretation

■Marine facies strata tilted. Dipping angle 50° on east decrease to 5° to west.

□Observed conjugated shear structures in 30~50°

The main shear plane cut through the top N7 layer.

Crack fillings can be found in layer N8. It might because the extension force made the crack perpendicular to the bedding of strata.

The Holocene marine facies strata is suggested on the top of the hanging wall.

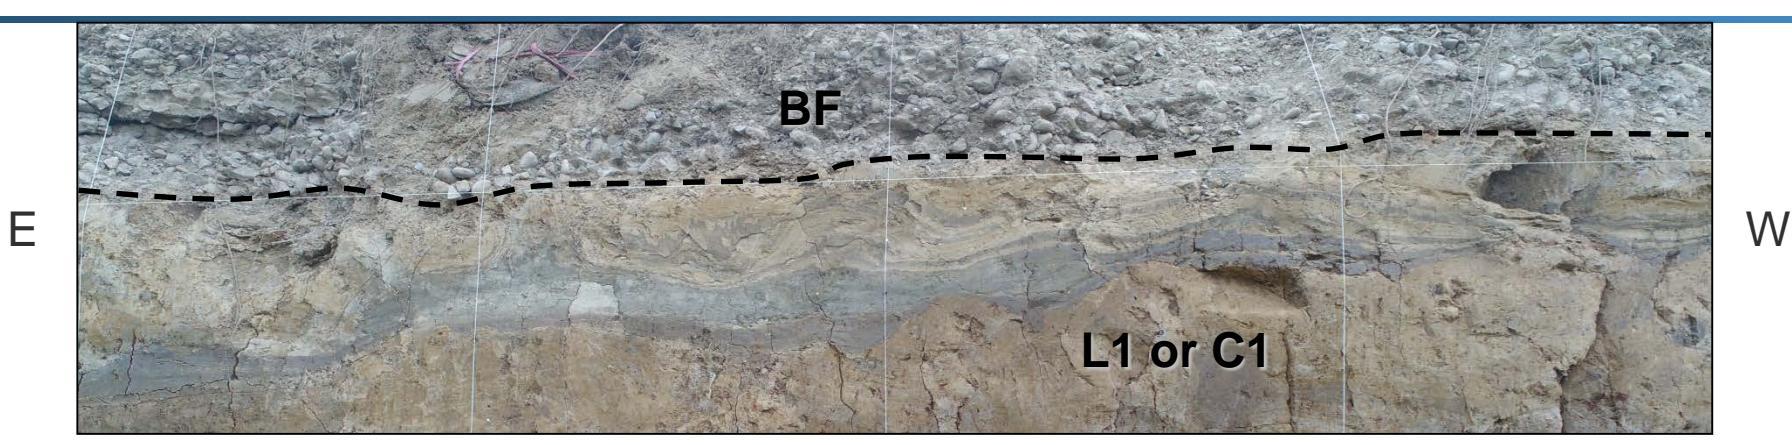
Geological structure interpretation

□The alluvium(L1 and C1) bedding is nearly flat without tilting.

L1 and C1 can found some flexure layer with liquefaction.

>This area located in the trishear zone of Liuchia fault.

- The faulting made the strata tilted and deformed strongly in the trishear zone.
- >The main fault didn't appear in our investigation.
- Base on the evidences of shear structures and tilting layers, the Liuchia fault trace is buried.
- Deformed and flexure strata in recent 9000 year show that the Liuchia fault is an active fault, which can be categorized in the first class. (Active in Holocene 11,700 BP)

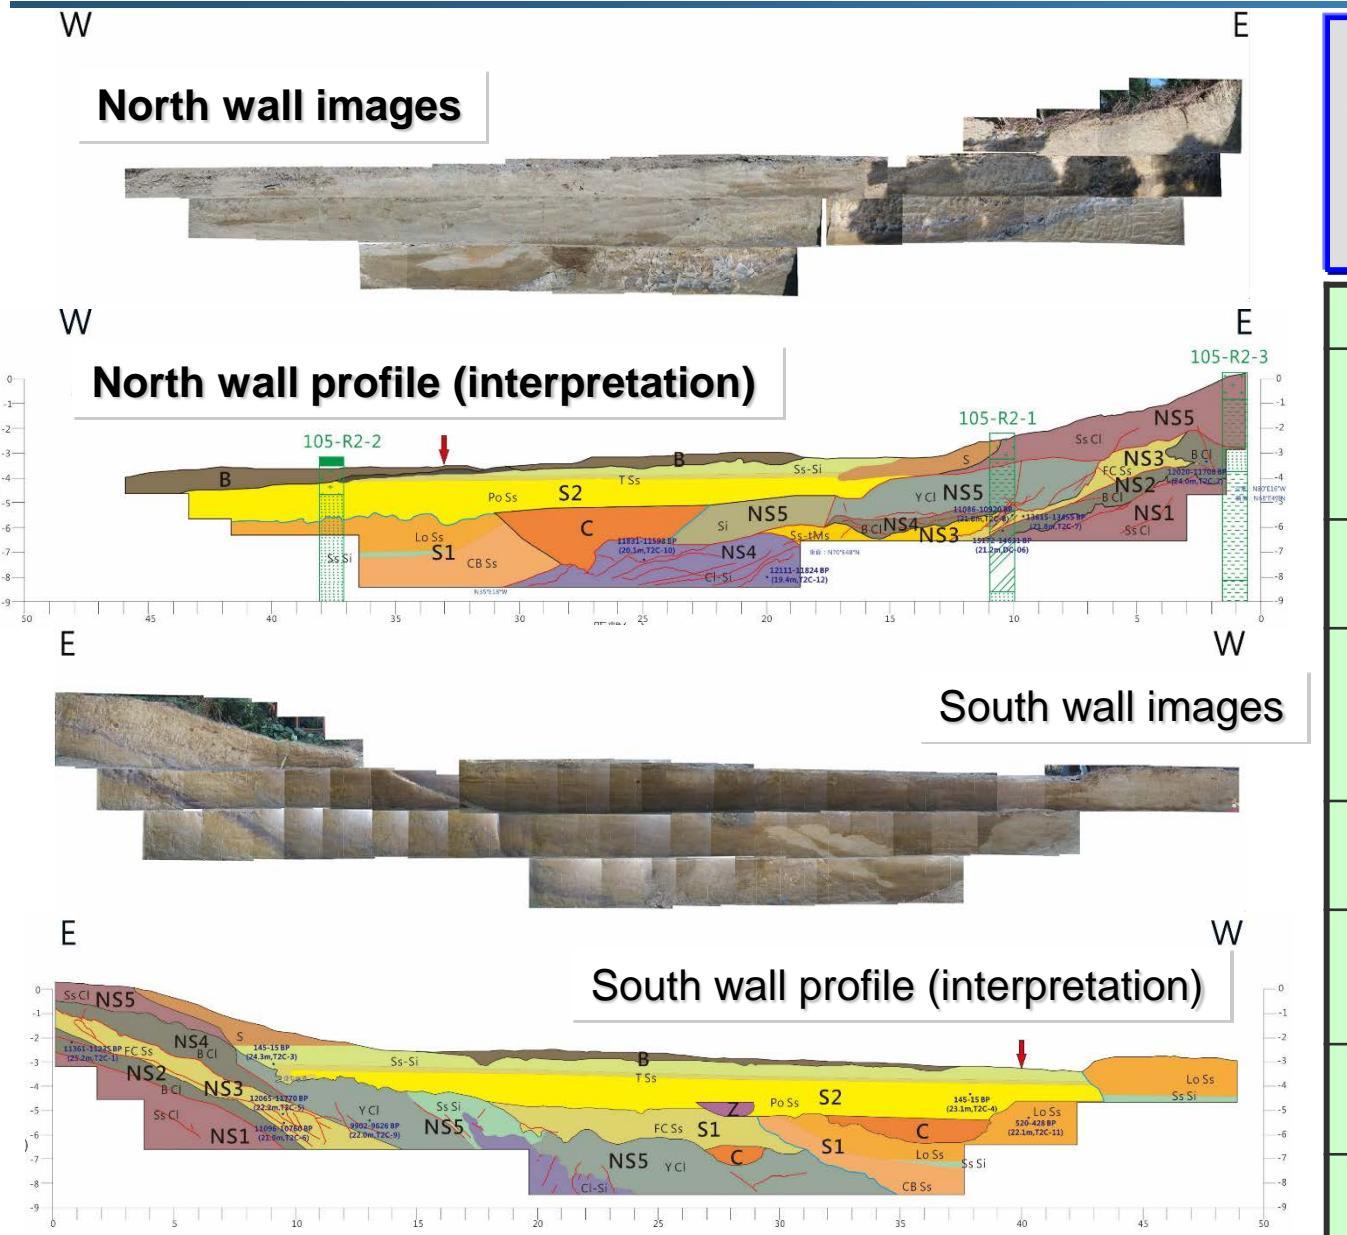
Site B trench walls profile

NS1~NS5 : Holocene marine facies strata S1~S2 : Alluvium B : Backfill

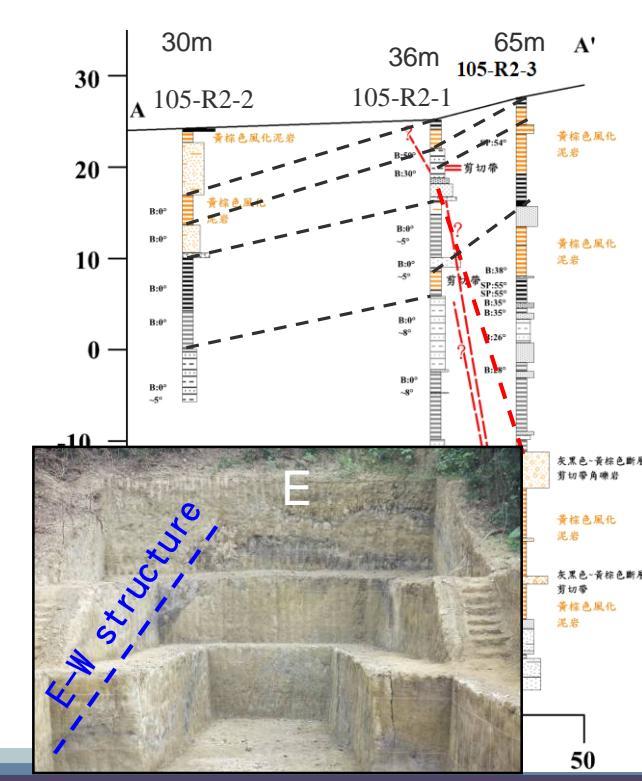
North wall profile

■Shear plane found on the west side S1 and S2 layer, which dipping to east. It can extend to NS4 organic clay layer.

There are several normal fault found in NS3 layer, which might be the fault dragging the Holocene marine facies strata.

Slickensides found on the east of the wall, which the surface dipping to north.

- There are no obvious stratigraphy throw showing in this trench site.
- Base on the evidence such as tilting strata, dense shear structures, the Liuchia fault trace is buried.

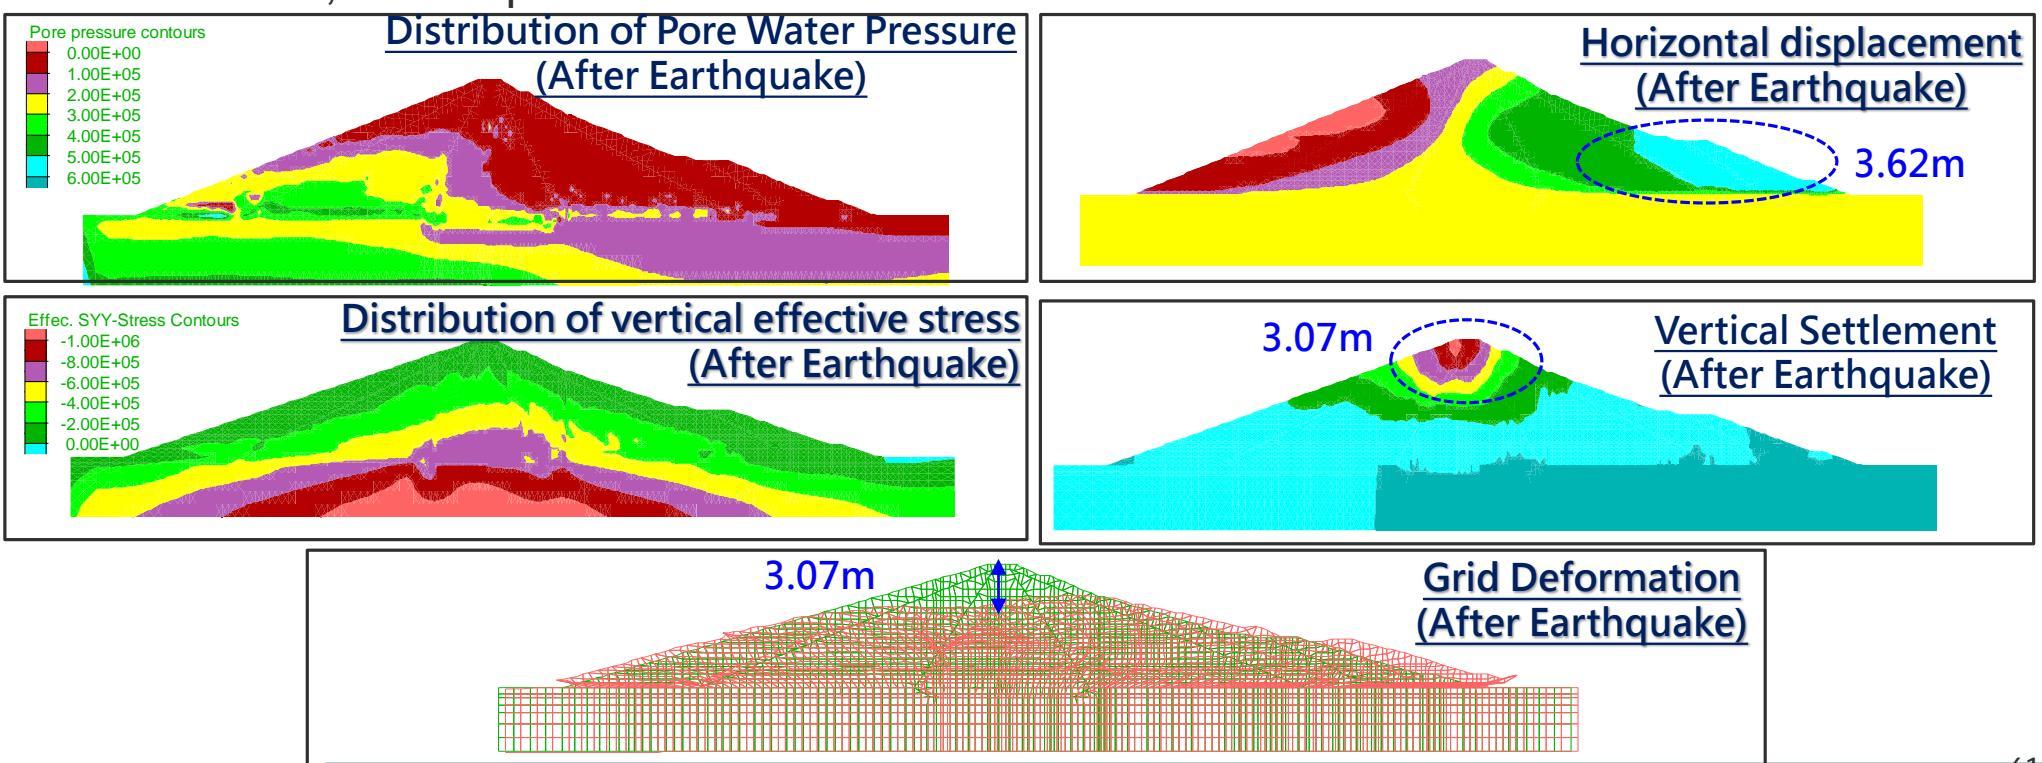
Maximum settlement is 3.07m (top of dam); Maximum horizontal displacement is 3.62m (down-stream slope).

Lost freeboard after earthquake is 3.0m, freeboard is still enough (Level of top of dam lower to EL.63.59m, and normal freeboard needed to reach is EL.61m)

According to USA California's Norms (deformation over 3m), earthquake-resistant ability is

insufficient, thus improvement is recommended.

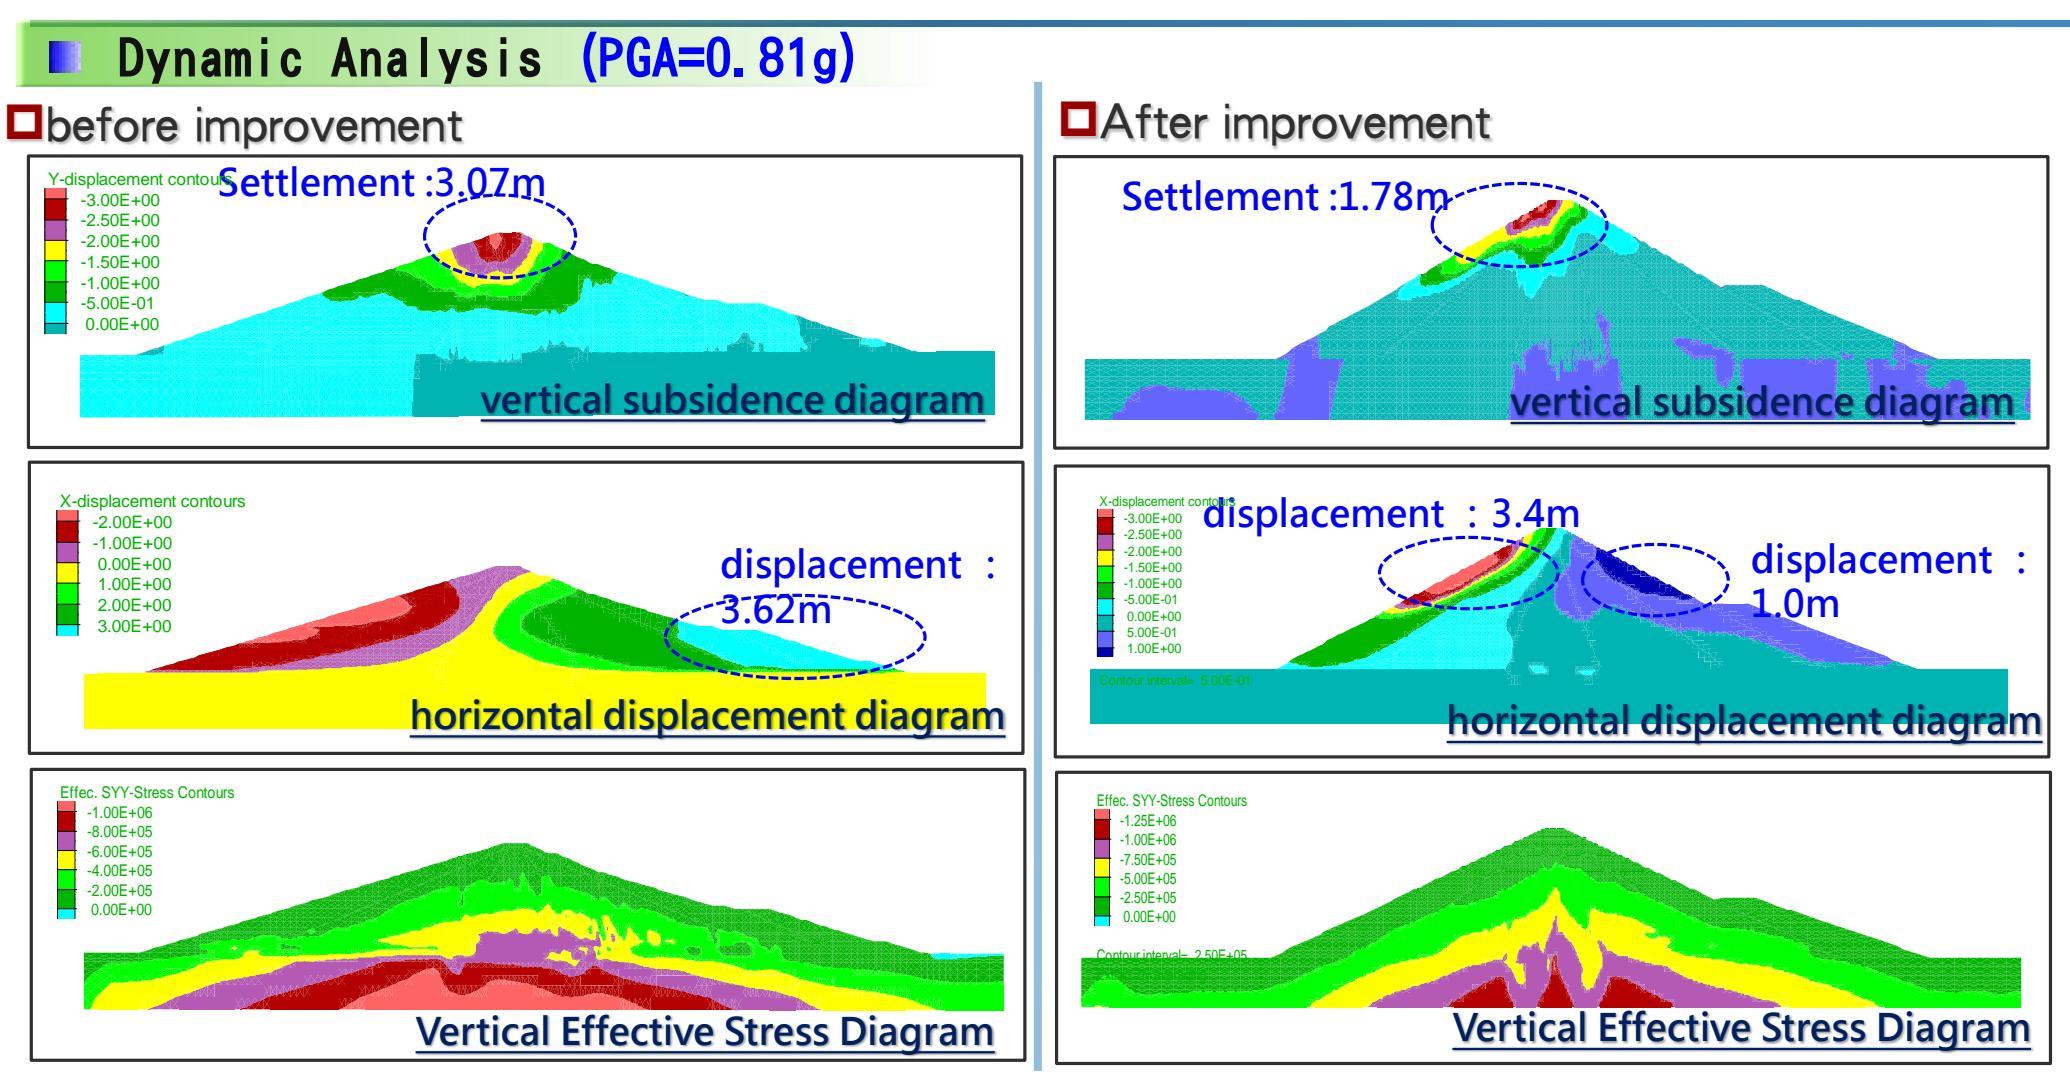
The maximum subsidence is 1.78 m (upstream side of the dam crest); the maximum horizontal displacement is 3.40 m (upstream slope surface).

After the earthquake, the lost water height was 1.78 m(EL.64.88m), which is enough(at least EL61m)
