The formation and breach of a short-lived landslide dam at Hsiaolin village, Taiwan – part I: Post-event reconstruction of dam geometry

Jia-Jyun Dong^{a,b,*}, Yun-Shan Li^a, Chyh-Yu Kuo^c, Rui-Tang Sung^d, Ming-Hsu Li^d, Chyi-Tyi Lee^a, Chien-Chih Chen^b, Wang-Ru Lee^e

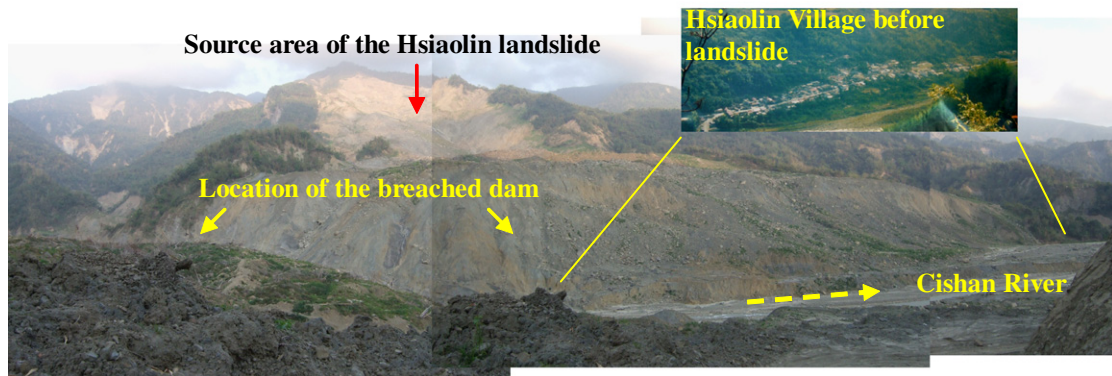
Fig. 1. The Hsiaolin landslide, the landslide dam and the buried Hsiaolin village. The landslide blocked the Cishan River and the landslide dam breached soon after the formation of an impounded lake. Blue line shows the drainage basin upstream of the Hsiaolin SLD. The boundary of the upstream catchment area is generated by the ArchHYDRO tool. The photo was taken from the west bank of the Cishan River shows the breached dam.

landslide dam and the location of the buried Hsiaolin village are shown in Fig. 1.

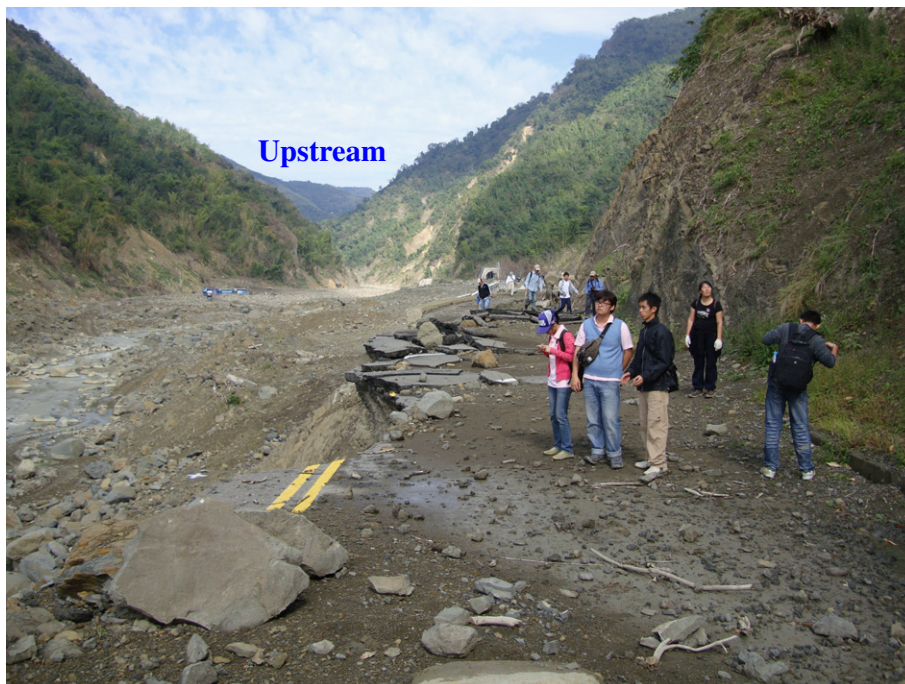
Fig. 5. The slightly damaged road immediately upstream of the landslide dam on the east bank of the Cishan River.

Field observations from upstream of the breached dam showed only minor damage on the east bank ([Figure 5](#)). It is postulated that, because the road is not buried by the landslide, it can be adopted as a constraint for the reconstruction of the dam geometry. In addition to sticks found hanging on the light at the tunnel, lake deposits of poorly sorted sand with few fines were found on the roof of a nearby house ([Figure 6](#)). This is evidence that the impounded water level exceeded Ele. 410 m. [Fig. 7](#) shows another house at Ele. 440 m in which evidence of water was found. Consequently, the impounded water level should possibly have been between Ele. 410–440 m.

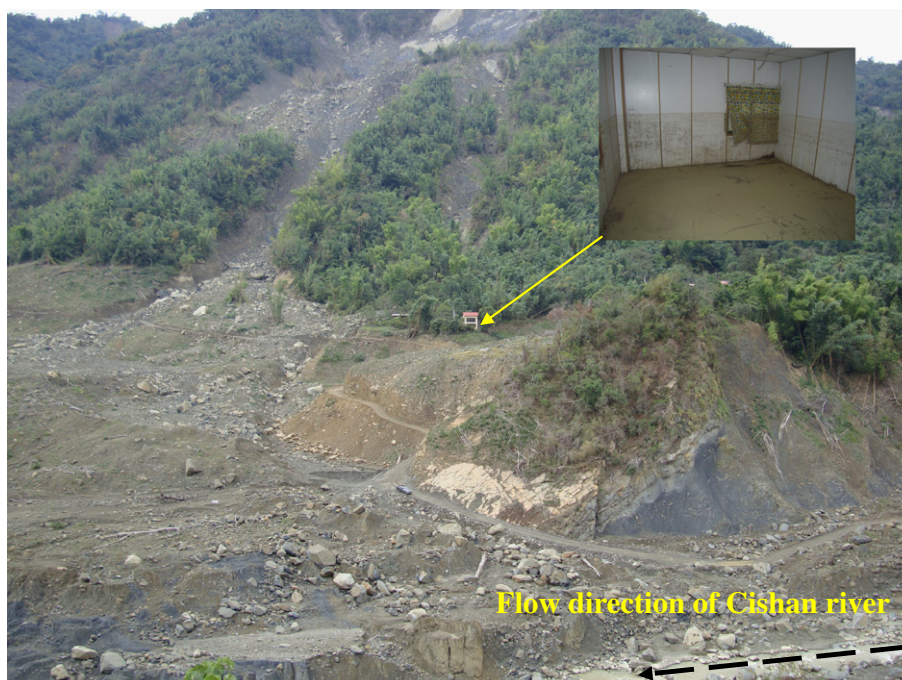
Fig. 7. Water traces were found in a house at about Ele. 440 m. Therefore, the maximum-possible impounded water level of the natural lake was Ele. 440 m.

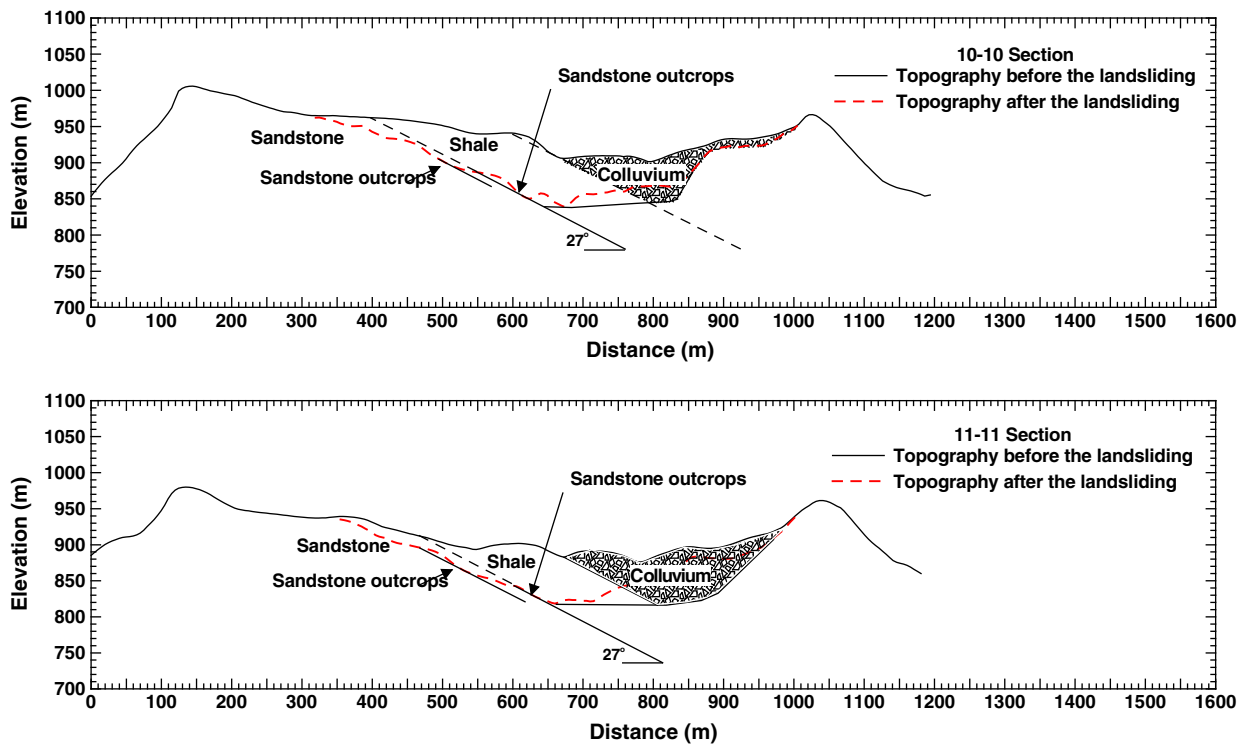
Fig. 12. Geological profiles of the Hsiaolin landslide. The locations of these two cross-sections are shown in Fig. 11.

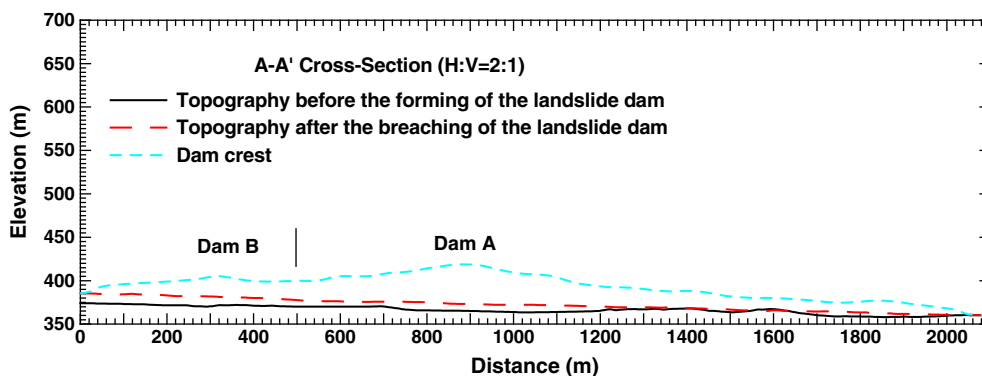
Fig. 16. A profile along the river (A-A'). The arrowmarks are the separation point between Dam A and Dam B.

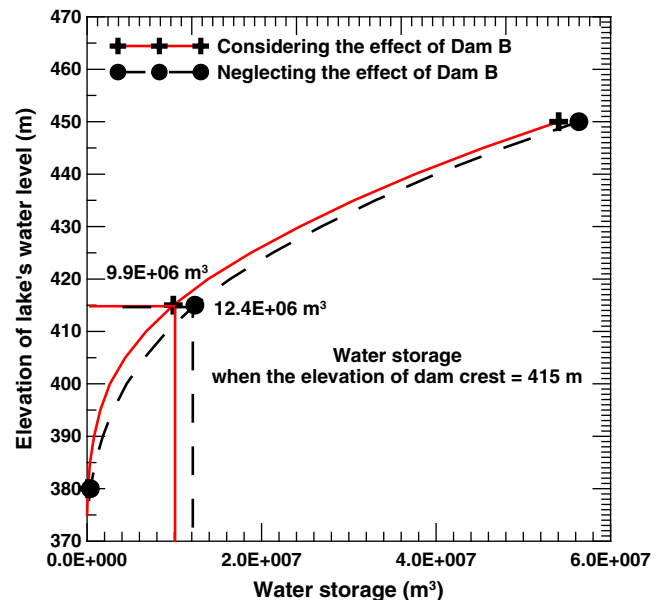
Fig. 18. The volume of impounded water versus the different elevations of the dam crest (overtopping point).

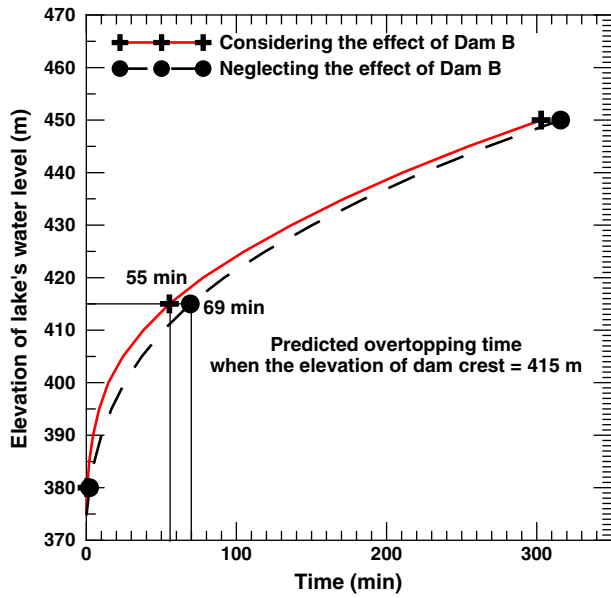
Fig. 19. The overtopping time versus the different elevations of the dam crest (overtopping point) under the simulated discharge of 2974 m³/s.
