Reconnaissance and learning after the February 6, 2018, earthquake in Hualien, Taiwan

Abstract

Keywords Seismic reconnaissance · 0206 Hualien earthquake · Milun fault · Near-fault ground motion · Building collapse · Bridge · Liquefaction · Non-structural component

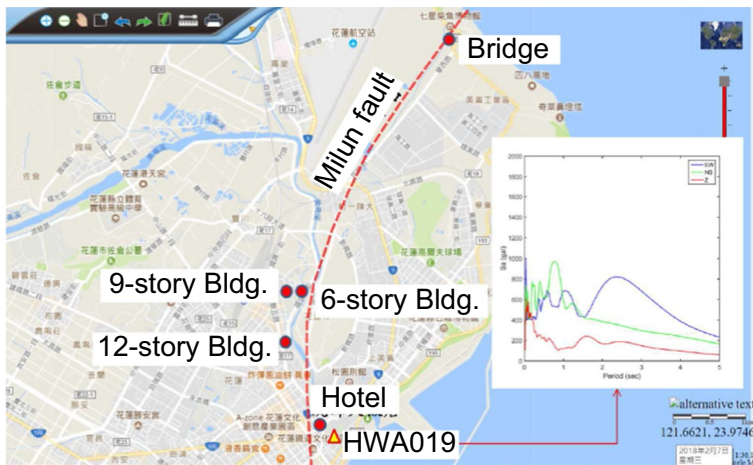
Fig. 7 Locations of the four collapsed buildings and one damaged bridge relative to the Milun Fault

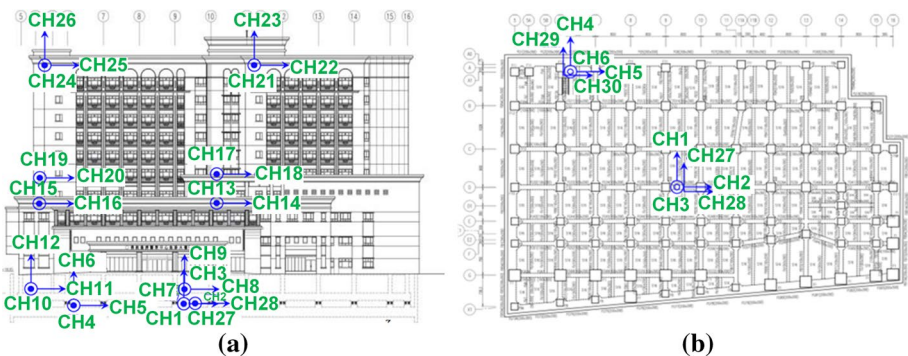
The base-isolated building (Fig. 13a) has been monitored with seismic instruments since the opening of the hospital. Figure 14 shows the layouts of the seismic instruments, including twenty-six channels for accelerators and four channels for displacement transducers. The four channels for displacement transducers are numbered CH27 to CH30 in Fig. 14b. The other numbered channels shown in Fig. 14 are for accelerators. Figure 15a–c show the acceleration histories in longitudinal, transverse, and vertical directions, respectively, recorded on the B2F level. In addition, the records obtained from the accelerometer located at the center of B2F (i.e., CH1 to CH3) are compared with those obtained from the accelerometer located at the corner of B2F (i.e., CH4 to CH6). Figure 15d–f are the counterparts of Fig. 15a–c for the roof’s acceleration records. The consistency between the acceleration histories recorded at the centers and corners of the floor plans (Fig. 15) indicates that there were no rotational responses, i.e., there were pure translations in both horizontal directions. These observed pure translations might have two meanings. One is that the building is symmetrical, i.e., it has no plane eccentricities. The other is that the accidental torsion stipulated in modern building codes (e.g., ASCE 2010; Eurocode-8 2003; CPAMI 2011)

Fig. 14 Layouts of seismic instruments in **a** elevation and **b** floor plan of B2F

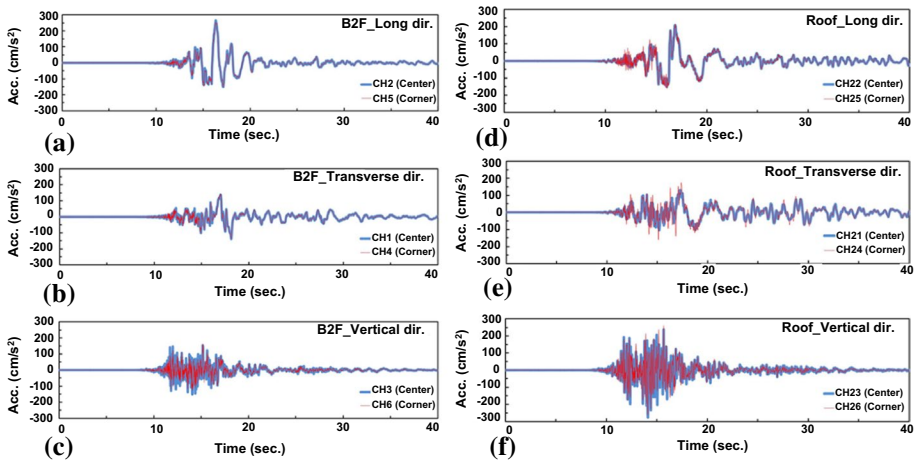
Fig. 15 Acceleration histories recorded at B2F in the **a** longitudinal, **b** transverse, and **c** vertical directions, and recorded at the roof in the **a** longitudinal, **b** transverse, and **c** vertical directions

Figure 15 also shows that the values of the longitudinal, transverse, and vertical peak accelerations are 209, 131, and 279 cm/s^2 , respectively, at the roof's center (Fig. 15d–f), and 266, 139, and 155 cm/s^2 , respectively, at the center of B2F (Fig. 15a–c). Therefore, the ratios of the longitudinal, transverse, and vertical peak accelerations recorded at the roof's center to those recorded at the center of B2F are 0.79, 0.94, and 1.8, respectively. In other words, the percentages of the reduced accelerations in the longitudinal and transverse directions were 21% and 6%, respectively, whereas the acceleration in the vertical direction increased by 80%. The acceleration response spectra corresponding to the ground motion records of strong motion station HWA019 (Fig. 5b) indicate large acceleration demands for structures with vibration periods of 2 to 4 s. Because both the designed first vibration periods in the longitudinal and transverse directions of this building (Fig. 13a) are 2.76 s, it is expected that the effect of the base isolation used in this building on reducing the peak accelerations was not significant in this seismic event. This unremarkable seismic performance of the base isolation indicates that the effect of near-fault ground motions on base-isolated buildings should be properly and thoughtfully considered. Moreover, it is clear that LRBs isolate horizontal ground accelerations rather than vertical ground accelerations. Therefore, considering that the vertical vibration period is very short, the 80% increment of the peak vertical acceleration of the roof in comparison with that of B2F appears reasonable.

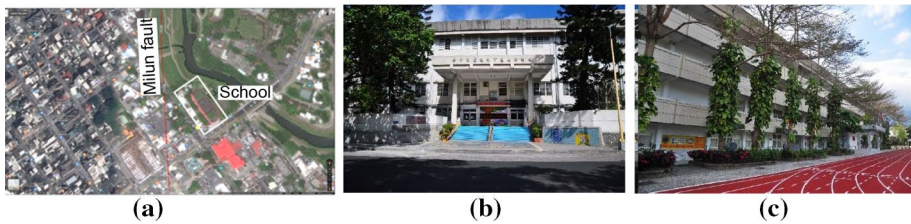
Fig. 17 **a** Map showing a school close to the Milun Fault. **b** Central front and **c** overall views of the school building

Figure 17a shows an elementary school close to the Milun Fault. The school has only one building, which has four stories and one basement floor constructed in 1990. This school building was retrofitted with enlarged columns, added shear walls, and wing walls

in 2011. Even though this school building is close to the Milun Fault, no structural damages were found in the building (Fig. 17b, c). Moreover, it is worth mentioning that two retrofitted buildings of a junior high school were intact during the 2016 Meinong earthquake. In contrast, two other buildings of the same school that had not been retrofitted at the time of the 2016 Meinong earthquake suffered obvious damages in that seismic event (Henry et al. 2017; Shen et al. 2016). Therefore, in addition to the aforementioned case of the 2016 Meinong earthquake, the results of the reconnaissance demonstrate again that the project of seismic evaluation and retrofitting of school buildings across Taiwan initiated in 2009 was quite successful.

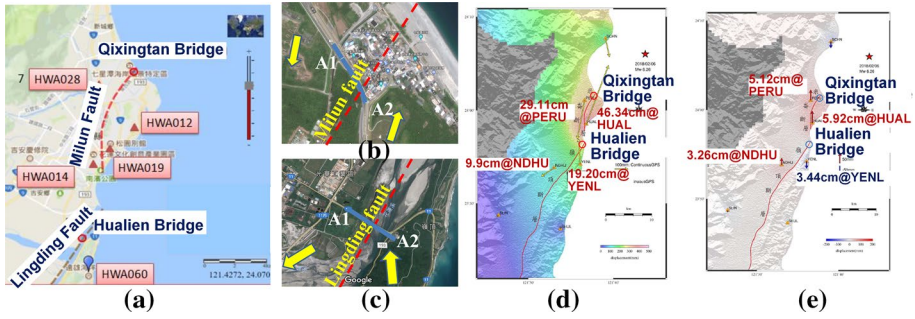
Figure 21d, e respectively show the horizontal and vertical displacements of land surfaces measured through the global positioning system (GPS) by Taiwan's

Fig. 21 a Locations of the Qixingtian Bridge and Hualien Bridge. b The direction of Qixingtian Bridge relative to the Milun Fault. c The direction of the Hualien Bridge relative to Lingding Fault. The d horizontal and e vertical displacements of land surfaces on the two sides of the Milun Fault and Lingding Fault (CGS 2018)

Central Geological Survey (CGS 2018). The lengths and directions of the arrows shown in Fig. 21d, e represent the magnitudes and directions of the displacements. The GPS monitoring stations HUAL and PERU are on the hanging wall (or east side) and footwall (or west side) of the Milun Fault, respectively. The horizontal displacements at the HUAL and PERU stations were 46.34 cm toward the north-east direction and 29.11 cm toward the south-west direction, respectively (Fig. 21d). That is to say, the relative horizontal displacement between the hanging wall and the footwall of the Milun Fault, dislocated in the Hualien earthquake, was over 70 cm. Additionally, the vertical displacements at the HUAL and PERU stations were 5.92 cm and 5.12 cm, respectively, both of which were upward (Fig. 21e). Moreover, the GPS monitoring stations YENL and NDHU are on the hanging wall (or east side) and footwall (or west side) of Lingding Fault, respectively. The horizontal displacements at the YENL and NDHU stations were 19.2 cm toward the north-west direction and 9.9 cm toward the south-west direction, respectively (Fig. 21d). The vertical displacements at the YENL and NDHU stations were downward 3.44 cm and upward 3.26 cm, respectively (Fig. 21e). The directions of the yellow arrows shown in Fig. 21b, c are the same as those of the arrows shown in Fig. 21d. Figure 21b, c clearly indicate that the overall land displacements of Qixingtian Bridge and Hualien Bridge were counterclockwise. Differential land displacements indeed existed in each of the bridges. In addition, the major land displacements of Qixingtian Bridge and Hualien Bridge were on the hanging wall (or east side), i.e., on the abutment A2 side.

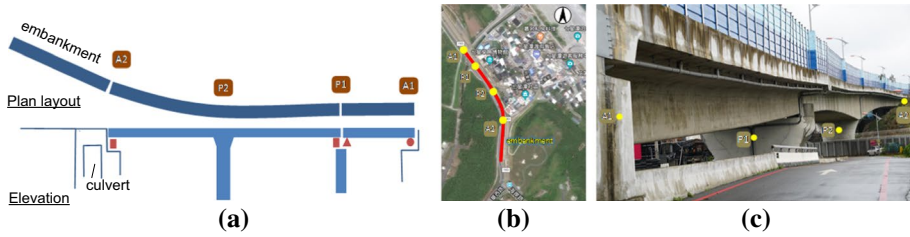
Figure 22a depicts a plan and elevation layouts of Qixingtian Bridge, which was opened for traffic in 2013. Abutment A1 to pier P1 is a 60-m-span simply supported vibration unit where the bearing at abutment A1 is longitudinally moveable and the bearing at pier P1 is a hinge. Pier P1 to abutment A2 is another vibration unit that is a two-span, 90 m + 90 m, continuous girder rigidly connected to pier P2 (Fig. 22a). In this two-span vibration unit, both the bearings at pier P1 and abutment A2 are moveable in the longitudinal direction and fixed in the transverse direction, and vertically adjustable. Abutment A2 is skewed relative to the direction of traffic flow. The superstructure of the bridge consists of

Fig. 22 Qixingtan Bridge: **a** diagrams of the plan and elevation layouts, **b** satellite image, and **c** photograph

pre-stressed concrete two-cell box girders. The substructure of the bridge is single-column RC piers with elliptical cross-sections and pile foundations. In addition, there is a culvert integrated with abutment A2 (Fig. 22a). Figure 22b, c show respectively a satellite image and a photograph of the Qixingtan Bridge. The serial numbers of the piers and abutments are marked in the photographs (Fig. 22b, c).

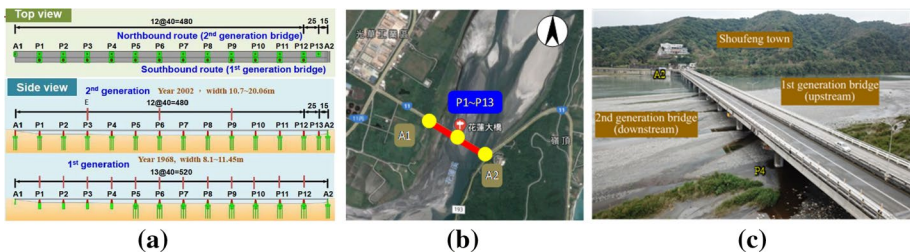
Figure 24a depicts top and side views of the Hualien Bridge, whose structures for the northbound and southbound routes are completely separated. The southbound and northbound routes, completed in 1968 and 2002, respectively, are designated as 1st- and 2nd-generation bridges (Fig. 24a). Both the 1st- and 2nd-generation bridges were seismically retrofitted in 2013. Figure 24b, c show the satellite image and a photograph of the Hualien Bridge, respectively. Figure 24a indicates the span layouts and the bridge widths. Each span of the 1st-generation bridge consists of simply supported pre-stressed I-shaped girders sitting on neoprene pads. Expansion joints are set between every two spans of the bridge. The substructure of the 1st-generation bridge consists of circular single-column piers supported by circular caissons. Additionally, the foundations of piers P5 to P12 were retrofitted with extended pile caps and added piles in 2013 (Fig. 24a). The layout of the 2nd-generation bridge is similar to that of the 1st-generation bridge except that the former has no caissons but only piles. Besides abutments A1 and A2, the expansion joints of the 2nd-generation bridge are installed only at piers P3, P6, P9, P12, and P13 (Fig. 24a). The hinge-connected bridge decks are above the other piers where expansion joints are not installed. The 2nd-generation bridge was retrofitted with enlarged RC piers and added piles in 2013.

Fig. 24 a Top and side views, b satellite image, and c photograph of Hualien Bridge

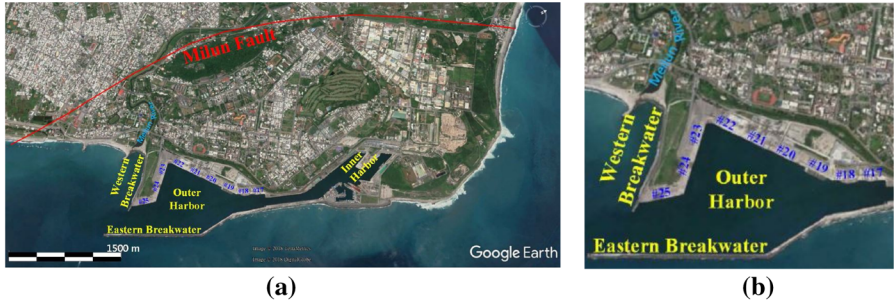
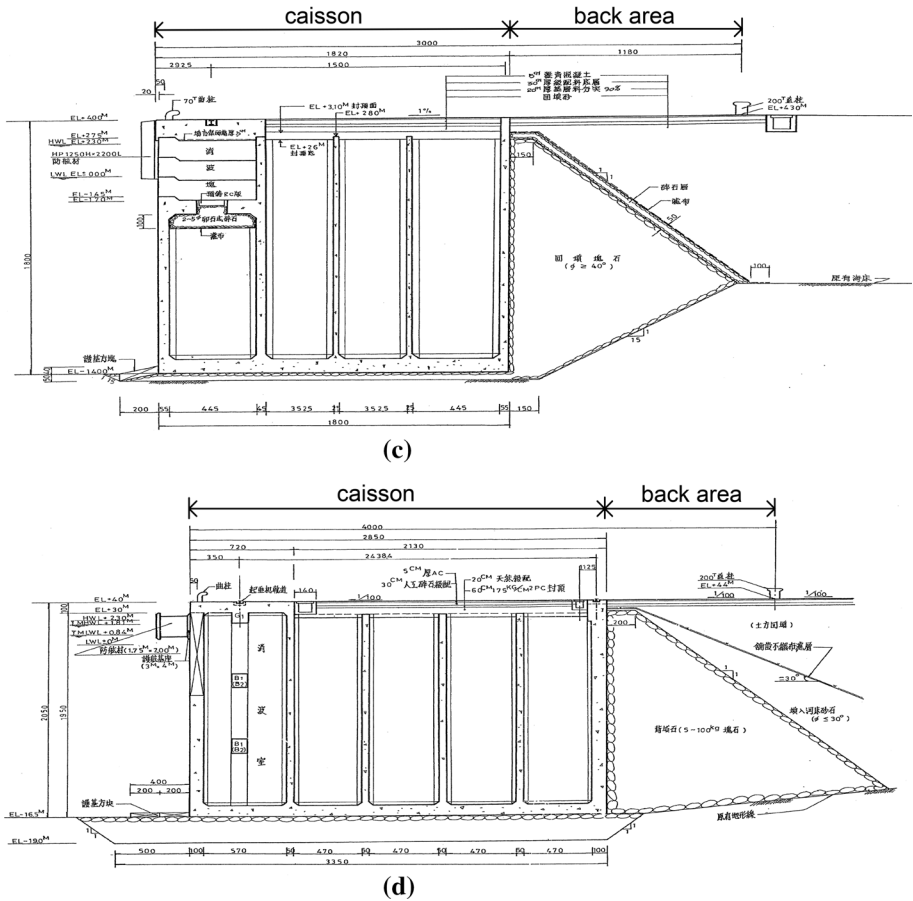
Significant liquefaction was observed at Hualien Port. Figure 27a shows the location of Hualien Port relative to the Milun Fault. Hualien Port consists of inner and outer harbors with 25 deep-water wharfs. Wharfs No. 1 to No. 16 and wharfs No. 17 to No. 25 are located in the inner and outer harbors, respectively. The outer harbor was completed in the final stage of an expansion project in 1991. The major liquefaction occurred at wharfs No. 23 to No. 25 as well as the western breakwater. Figure 27b, magnified from Fig. 27a, shows the locations of wharfs No. 17 to No. 25. Because the direction of wharf No. 25 is approximately 135° clockwise from the direction of wharf No. 24 (Fig. 27b), there is a transition wharf at the turning corner, i.e., between wharfs No. 24 and No. 25. Figure 27c, d show the cross sections of the gravity-type caissons of wharfs Nos. 23 and 24 and wharf No. 25, respectively. The back areas of the caissons shown in Fig. 27c, d were backfilled with gravels and sands.

The settlement of back area of wharf No. 23 was approximately 200 mm (Fig. 28a). Besides sands accumulated at some points of wharf No. 23, the border between the caissons and the back area was cracked (Fig. 28a). Nevertheless, the caissons of wharf No. 23 were not damaged, displaced, or settled. Figure 28b, c are images from closed-circuit television (CCTV) installed at wharf No. 23 with recording times at respectively 23:50:51 and 23:51:16 on February 6, 2018. The two recording times, separated by only 25 s, are before and after the strong shaking of the Hualien earthquake. Comparing the two images shows the spurt of underground water and cracks in the pavements caused by the ground shaking. With the CCTV images, the accumulated sands, settlements, and cracks collectively indicate that soil liquefaction happened in this area. The damages to wharf No. 24 shown in Fig. 28d, e were similar to those of wharf No. 23, but the settlement of its back area, which was approximately equal to 200–300 mm (Fig. 28d), was more significant in comparison with that of wharf No. 23. In addition, there was an approximately 90 mm gap between the wave chambers of wharf No. 24 (Fig. 28f) near the turning corner of the wharf, i.e., the side close to wharf No. 25 (Fig. 27b).

Fig. 27 Hualien port: **a** satellite image, **b** magnification of **a**, **c** cross-section of wharves No. 23 and No. 24, and **d** cross-section of wharf No. 25
