風險評估與管理 – 捷運建設的經驗

Risk Assessment and Management

- Lessons Learnt in Metro Projects

闕河淵 H.Y. Chuay

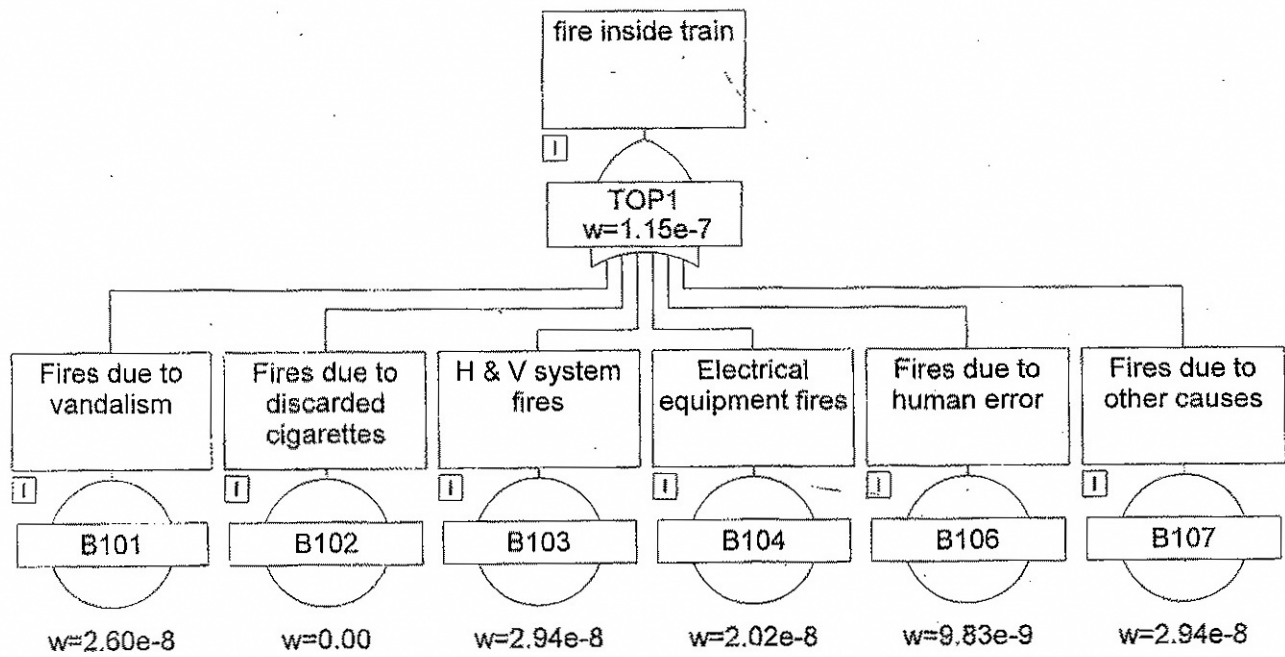
Fault Tree Analysis, FTA 災害樹分析

- Data base from UK EMU operation of 34 years
- Data from KCRC EMU operation of 14 years
- Internal fire event: 20 month return period
- External fire event: 15 month return period

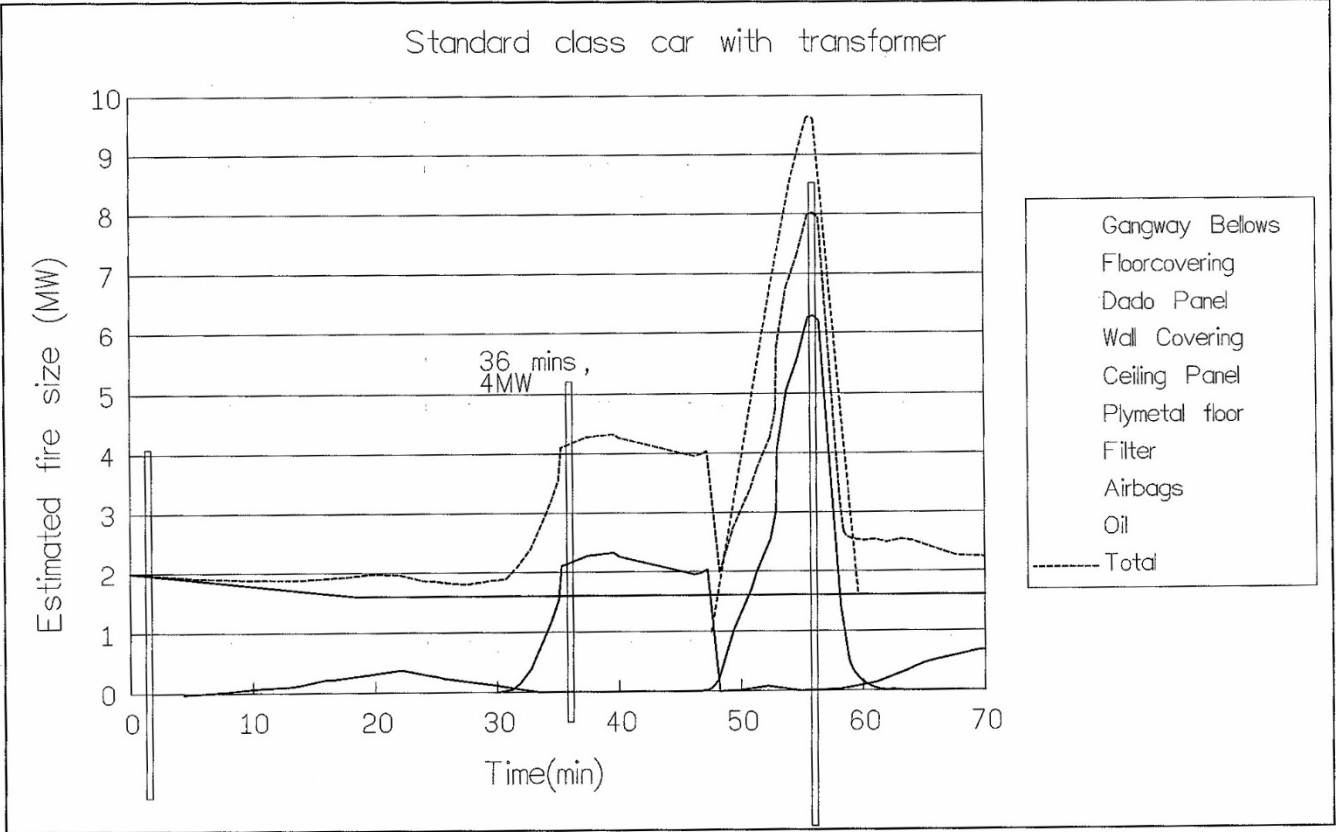
Standard Fire Curve for DFRA and QRA Tunnel Fire Analysis

1.5 mins ,
2MW

56 mins ,
10MW

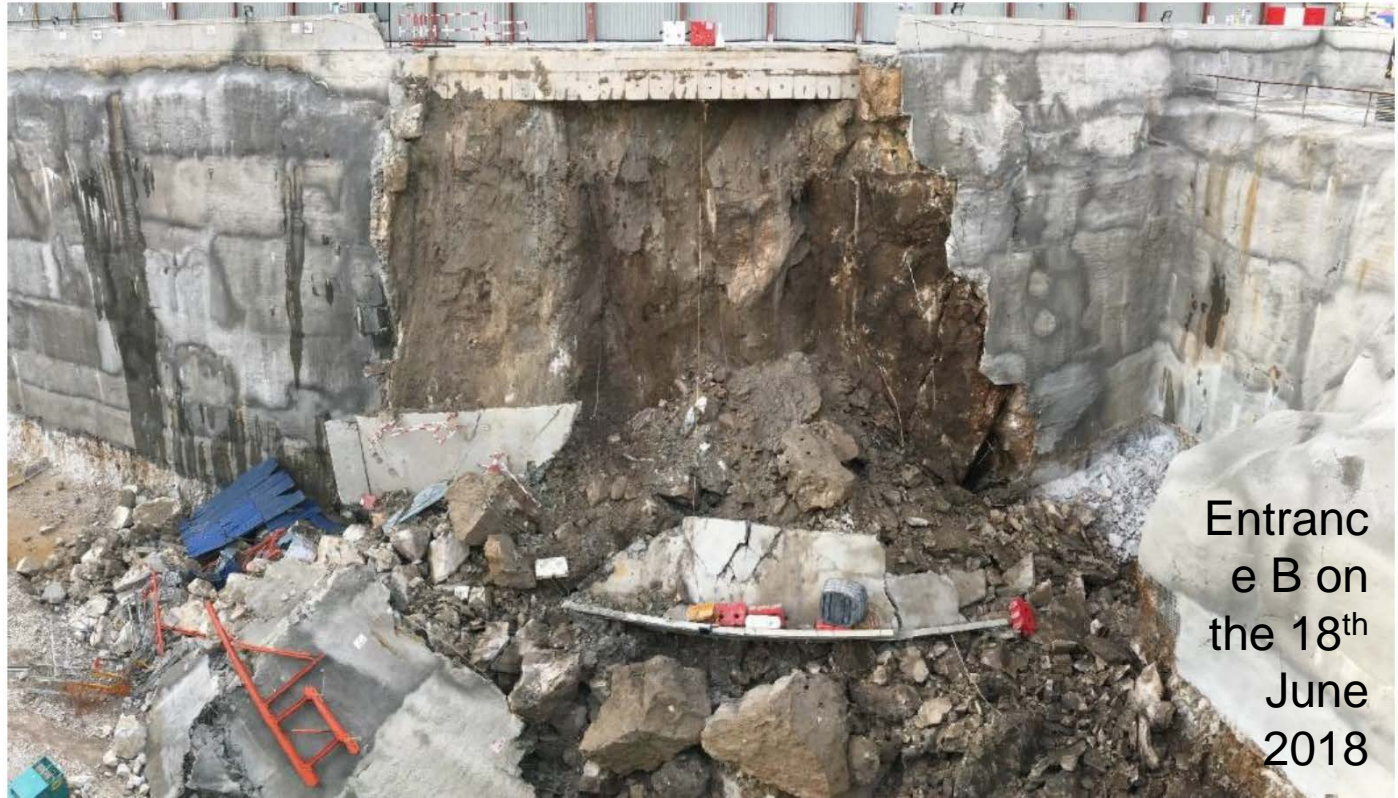
Example of What Could Go Wrong

Example of localized ground loss (rock slip) due to unforeseen rock joint formation behind exposed rock face.

Despite extensive soil investigation and geophysics work were
