Geological investigation and the influence estimation of WuShentou Dam via LiuChia

Senior Engineer Cheng-Yang Yen

E ENGINEERING CONSULTANTS CO., LTD

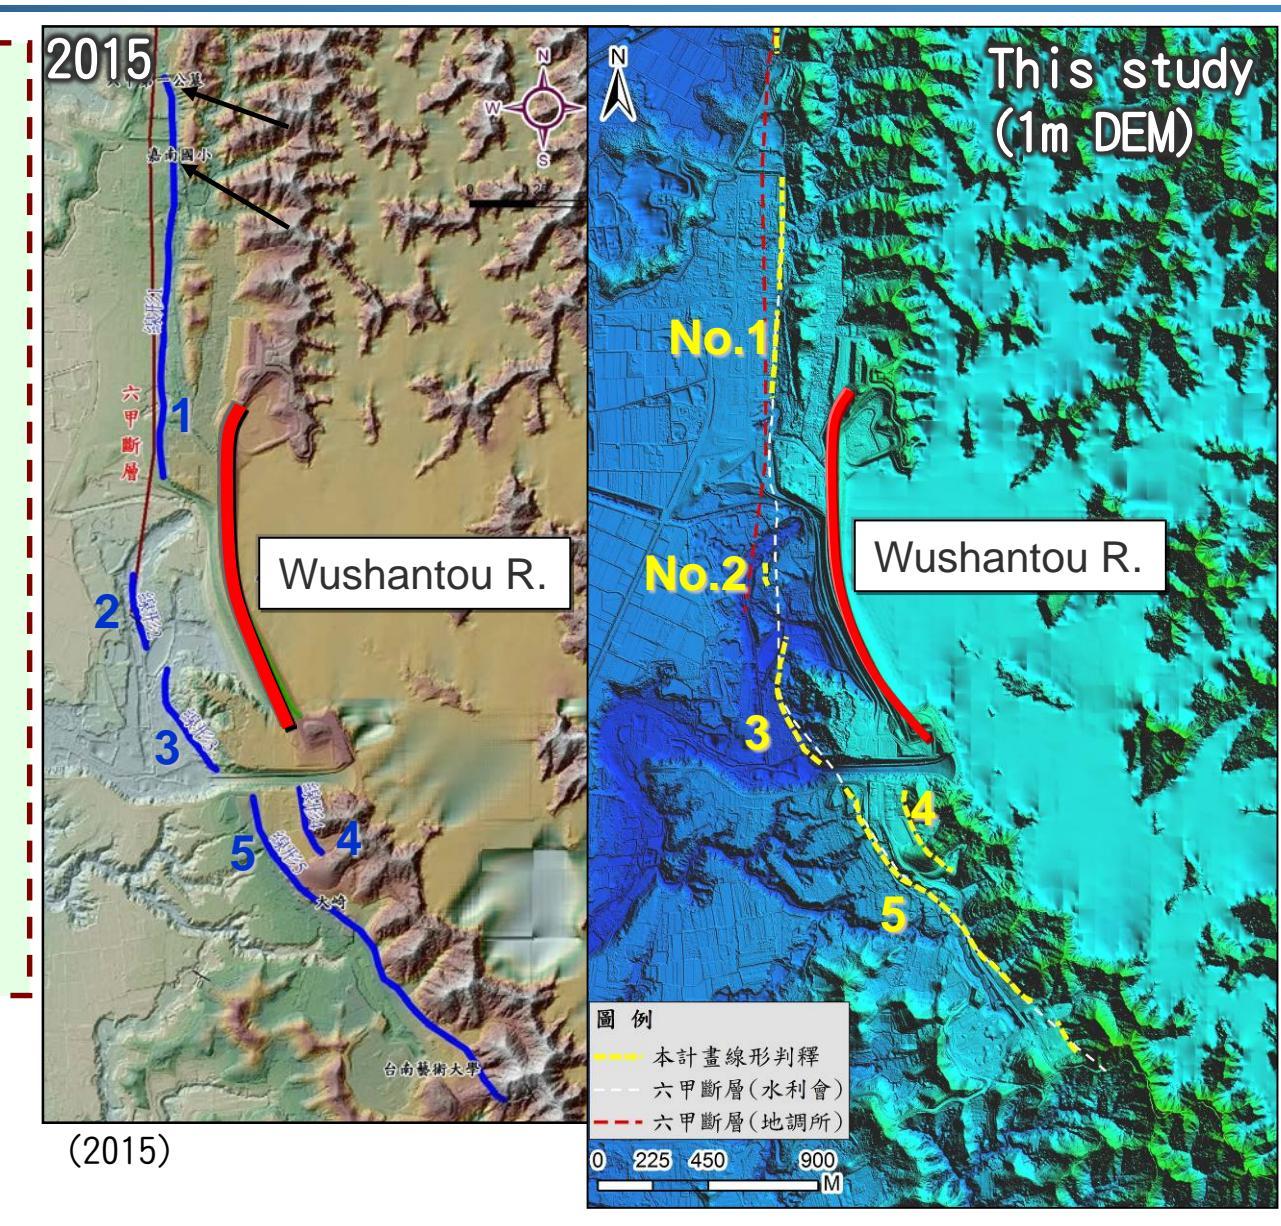
- Possible lineation of the fault scarp can be found near the Wushantou Reservoir.
- Those lineation are N-S direction with an arc shape.
- The topography lineation No.1 and No.2 located the fault trace that the CGS defined.
- The results show that the possible fault scarp lineation located in the west of Wushantou Reservoir.

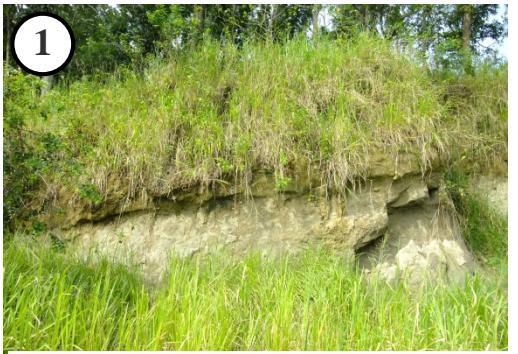
Thick Sandstone layer dipping 10° to west

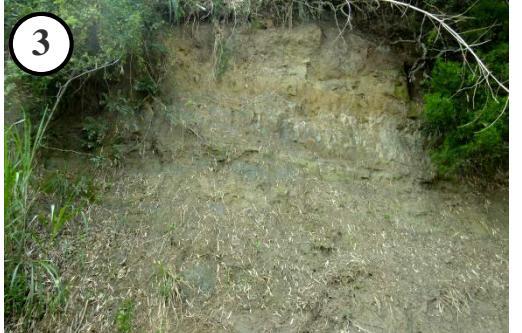
Sandstone and thin mudstone interlayer dipping 20° to west to west

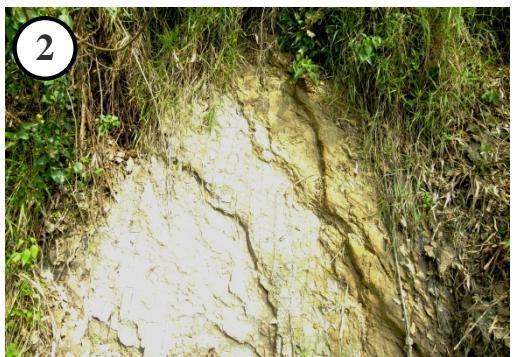
Shattered Sandstone and mudstone interlayer dipping 45° to west

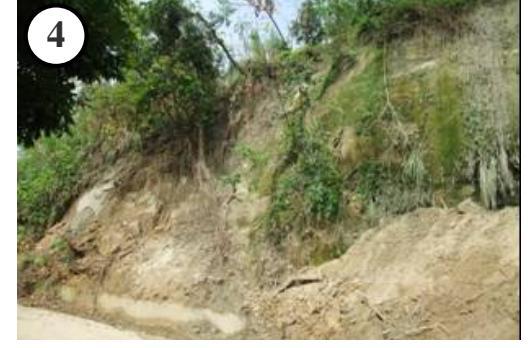
Thick sandstone layer dipping $10^\circ\,$ to west

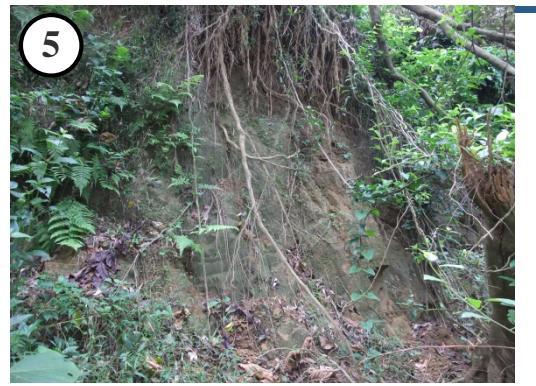
Thick sandstone with out shatterd

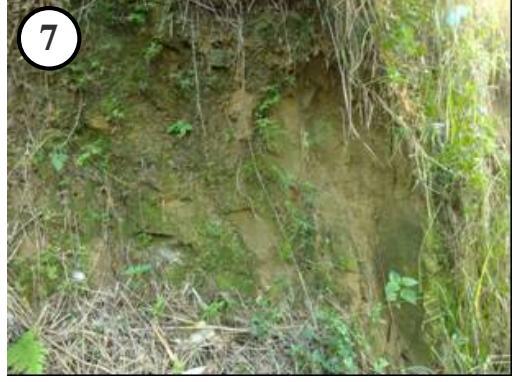
Stratiform sandstone dipping 20 to west

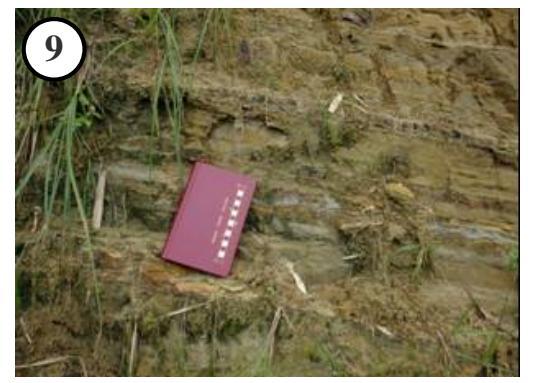
Ss and Mds interlayer

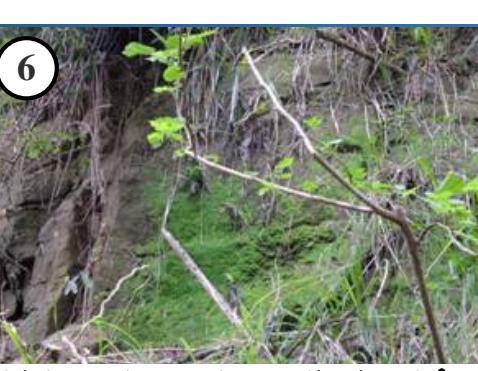
Thick sandstone layer dipping 15° to west

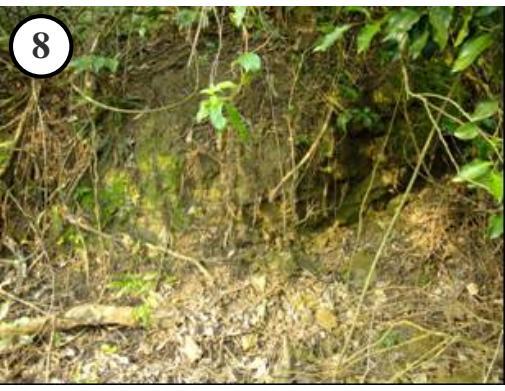
Stratiform sandstone dipping 16to west

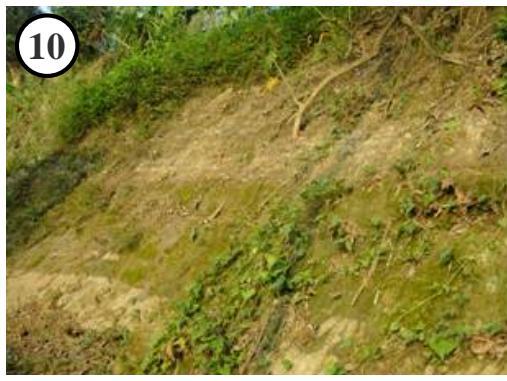
Thick Ss dipping 5 to west

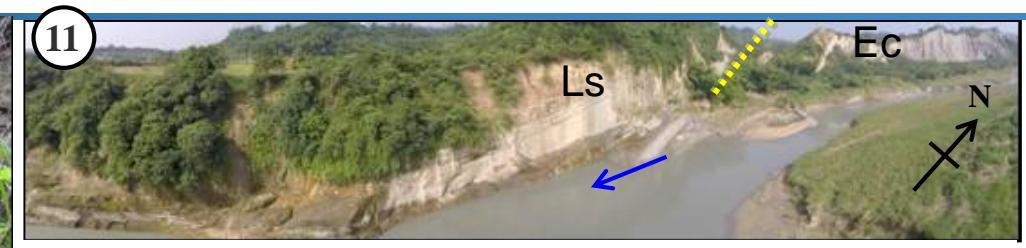
Undeformed strata on the riverbank, dipping to west

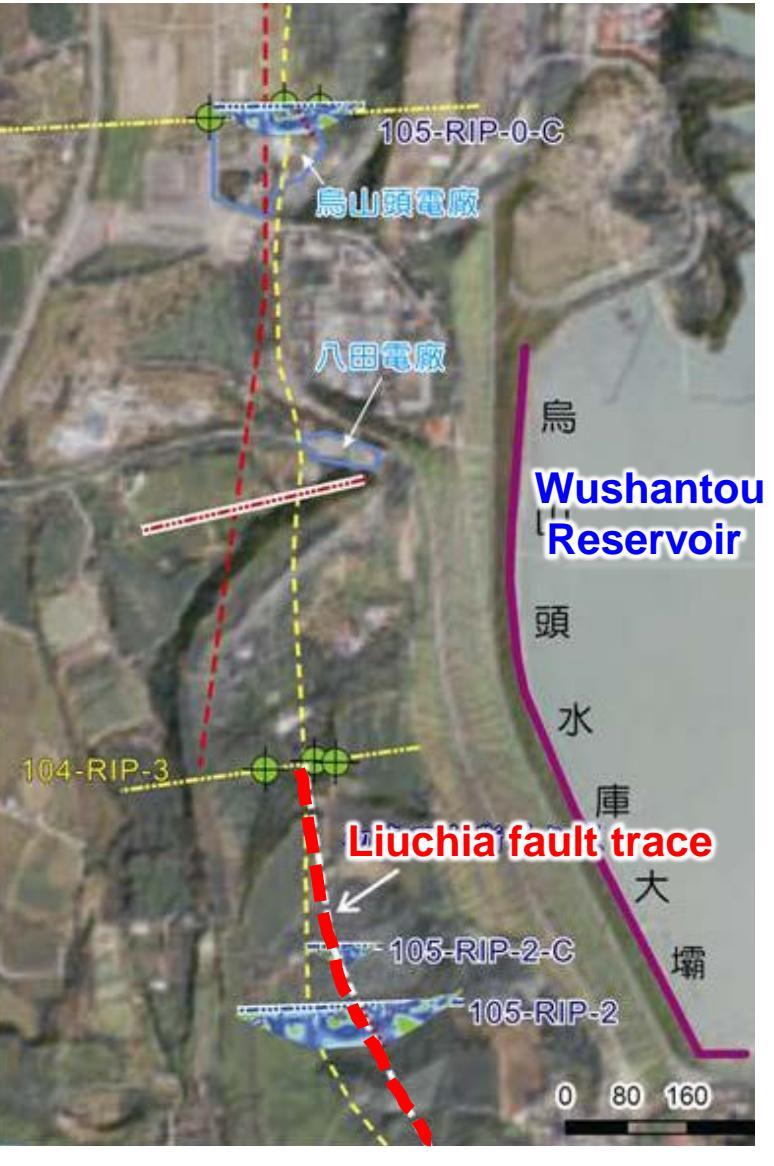
South part 105-RIP-3

- ✓ The survey line length is about 450~550 m.
- Resistivity unconformities region dipping to NE direction.
- It suggests that the characteristics are matched to the distribution of the Dam area

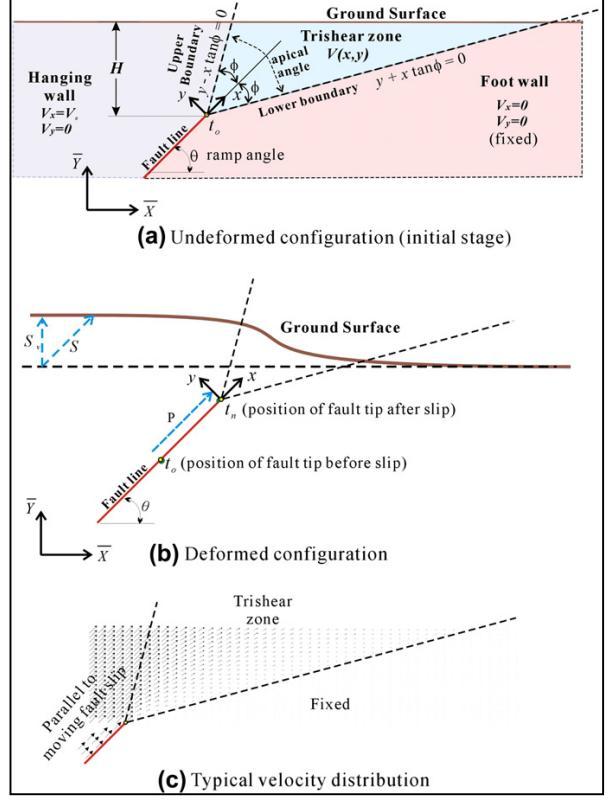
□The alluvium(L1 and C1) bedding is nearly flat without tilting.

L1 and C1 can found some flexure layer with liquefaction.

>This area located in the trishear zone of Liuchia fault.

- The faulting made the strata tilted and deformed strongly in the trishear zone.
- >The main fault didn't appear in our investigation.
- Base on the evidences of shear structures and tilting layers, the Liuchia fault trace is buried.
- Deformed and flexure strata in recent 9000 year show that the Liuchia fault is an active fault, which can be categorized in the first class. (Active in Holocene 11,700 BP)

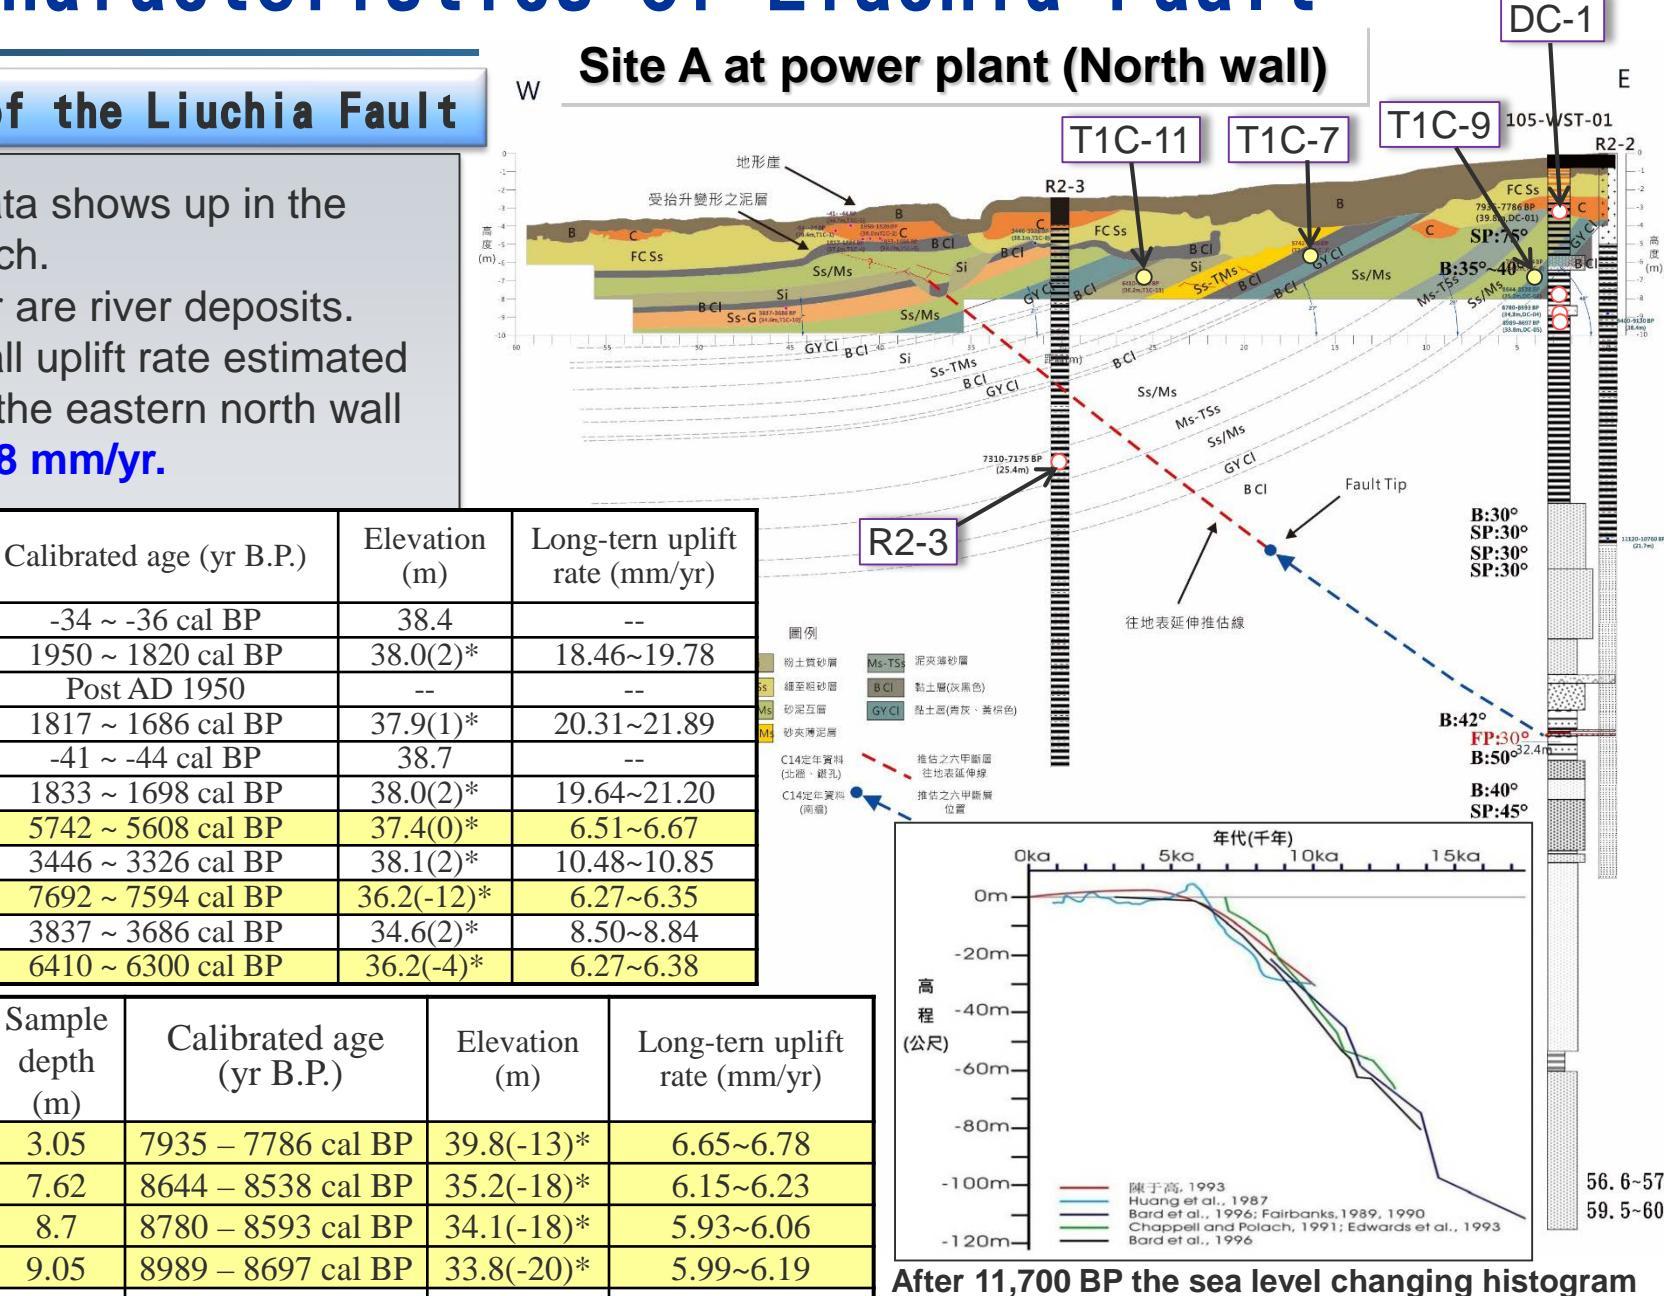
Land facies strata shows up in the middle of the trench.

□Part of the layer are river deposits. The hanging wall uplift rate estimated via the data from the eastern north wall which is **5.93~6.78 mm/yr**.

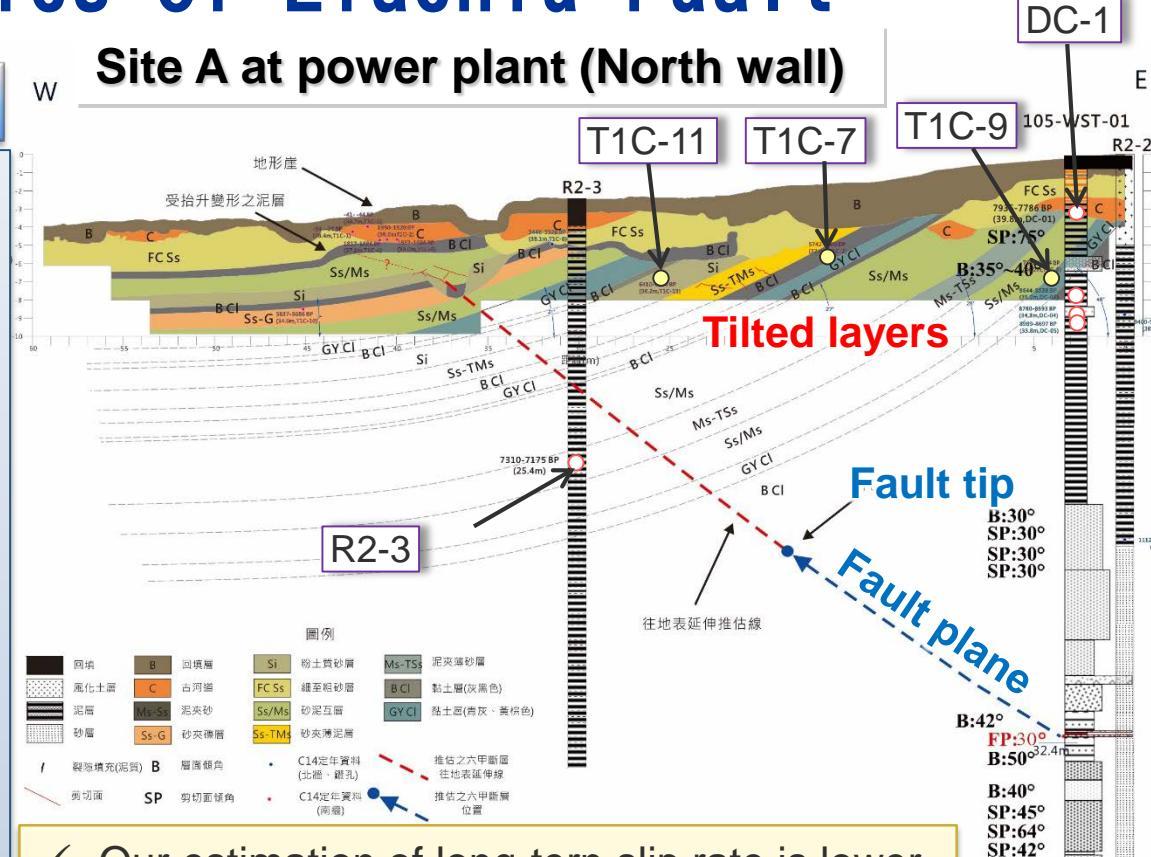
It is hard to define the direct fault slip rate because of the Liuchia fault didn't cut through the subsurface.

■Via the deformed sedimented layer, we can estimate the uplift rate of the buried Liuchia fault.

DC-01 age is 7835~7786 Cal BP **D**R2-3 age is 7310~7175 Cal BP, that means when the layer start to deposit, DC-01's elevation is lower than R2-3' s. Because of the faulting event let the DC-01 thrust up onto the R2-3's elevation. The 105-WS-1 well at depth 32.3m has fault gouge and breccia contacts, we can estimate the fault surface is dipping ~30° ➢ Previous research presented that the footwall long-tern uplift rate is 4.9 ± 0.2 mm/yr (R2-3), hence, the Liuchia fault's long-tern slip rate can be **3.10~4.16 mm/yr**

- ✓ Our estimation of long-tern slip rate is lower than the rate which Young et al.(2005) and Chen et al.(2006) published(11.0~12.7 mm/yr).
- It suggests that our study area might be the end tip of Liuchia fault.
 - The fault did not cut through the surface with buried fault trace. Only cause the subsurface layer deformed and tilted.

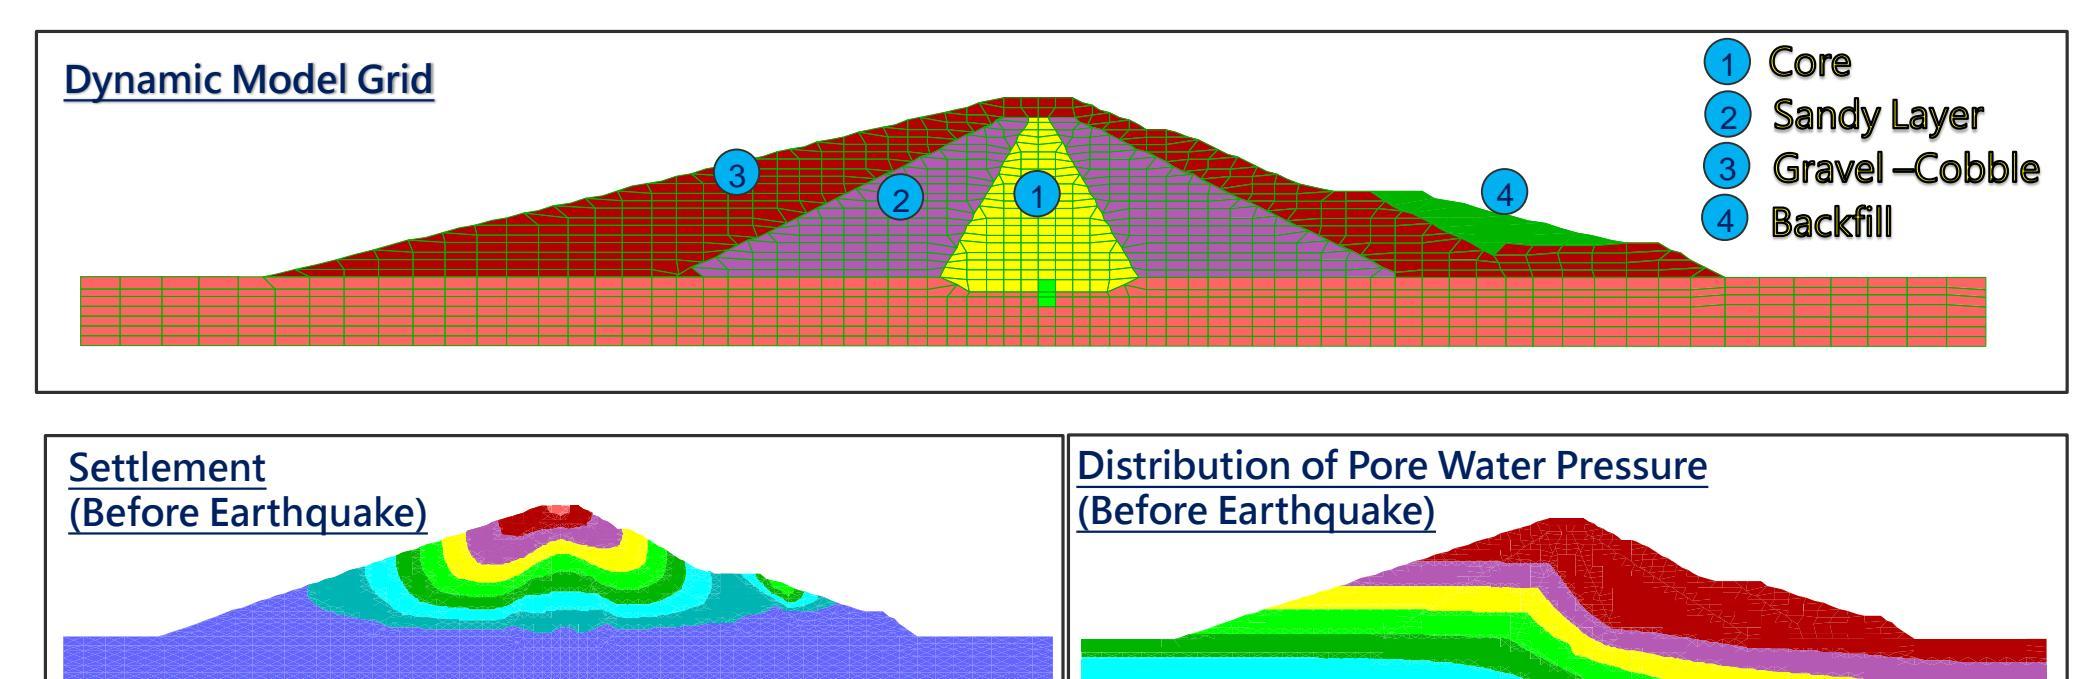
Maximum settlement is 3.07m (top of dam); Maximum horizontal displacement is 3.62m (down-stream slope).

Lost freeboard after earthquake is 3.0m, freeboard is still enough (Level of top of dam lower to EL.63.59m, and normal freeboard needed to reach is EL.61m)

According to USA California's Norms (deformation over 3m), earthquake-resistant ability is

insufficient, thus improvement is recommended.

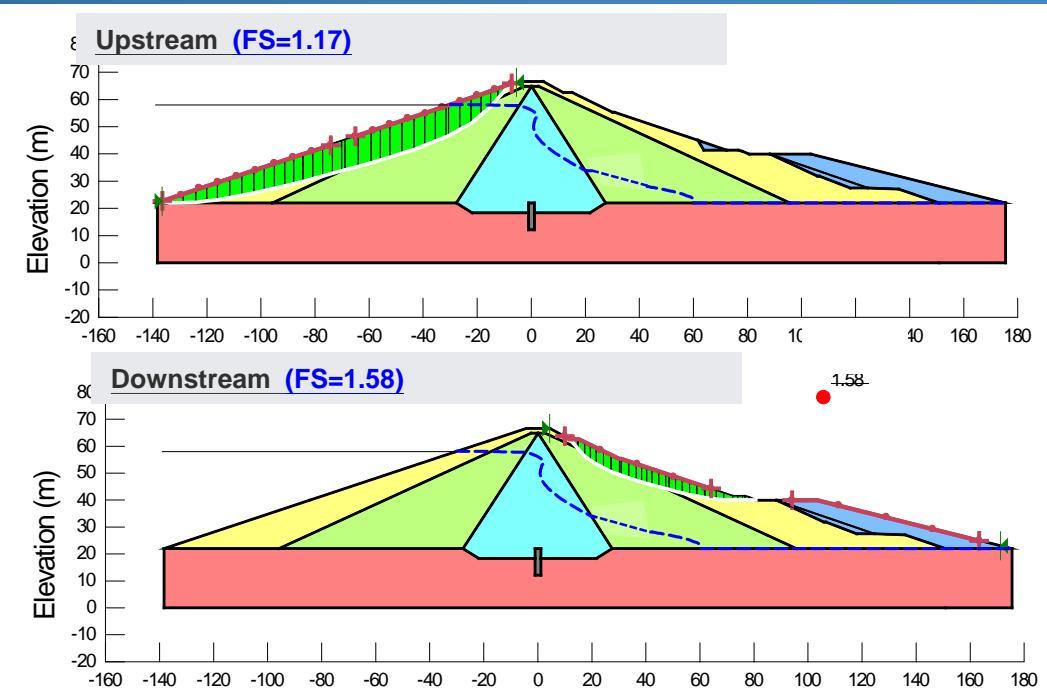
- ◆ 2D Finite Element Program : SLOPE/W
- Situation :
 - stability analysis under steady seepage
 - stability analysis during sudden release
 - Stability Analysis when earthquake

◆The upstream and downstream of the improved dam are safe in all conditions.
